# ENCOUNTERING THE SHAKERS OF THE NORTH FAMILY LOT, UNION VILLAGE, OHIO

## *A Clean and Lively Appearance — Landscape and Architecture of the North Family Lot*

VOLUME 2 OF A 4-VOLUME MONOGRAPH SERIES

January 30, 2009

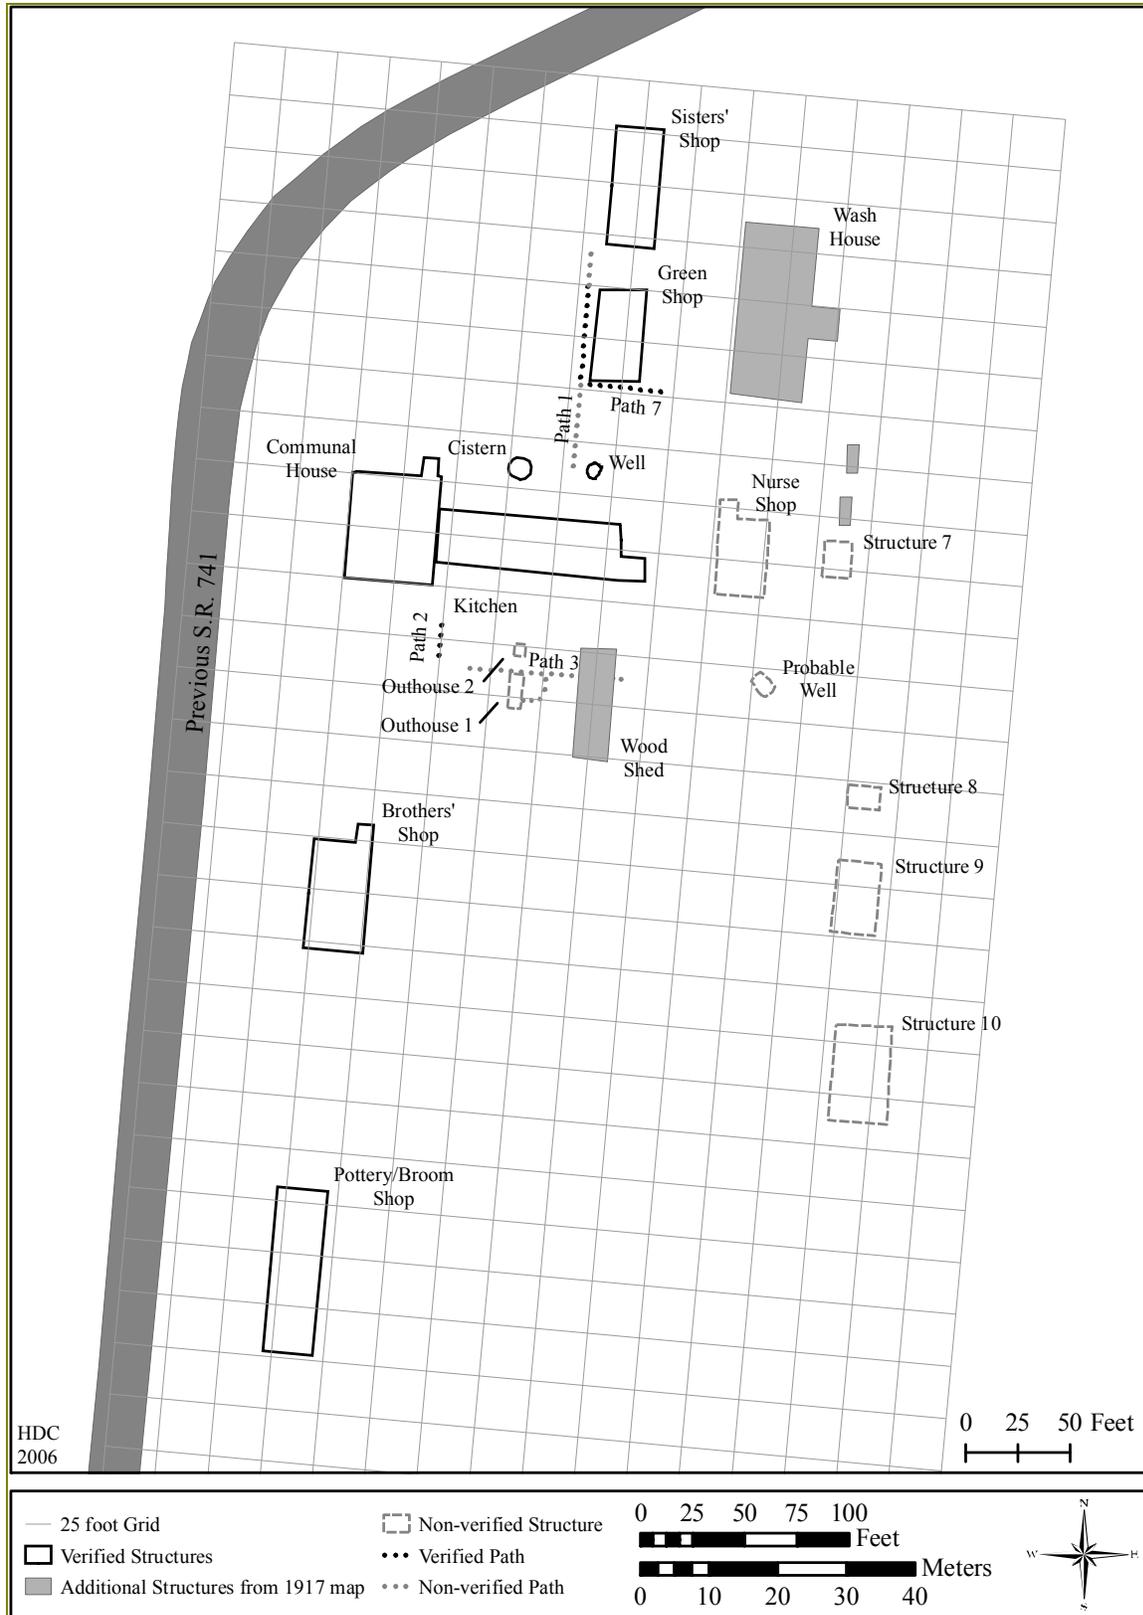
Figure 18. North Family Lot plan with 25-foot grid

In the case of the North Family Lot, building locations may have been guided by a grid with intervals of 25 feet. Other authors have noted the even spacing and grid-like patterns of building placement within Shaker communities (Fiegel 1995, McBride 1995). After we identified as many definite building locations as possible at the North Family Lot, we experimented with overlaying grids of different intervals on the site plan to look for evidence that the buildings were aligned along a grid. We tested various types of measurements that the Shakers may have used—chains, rods, and feet—and measured the distance between the three earliest buildings (the Communal House, the Brothers’ Shop, and the original smithy foundation of the Pottery/Broom Shop). Experiments with chains and rods did not result in a grid interval that fit the arrangement of buildings, but we noted that several buildings seemed to have long axes that were close to 50 feet in length (the Communal House, Brothers’ Shop, Green Shop, Nurse Shop, Pottery/Broom Shop addition, Sisters’ Shop, and an unidentified structure found in the southeast corner of the lot during geophysical survey).

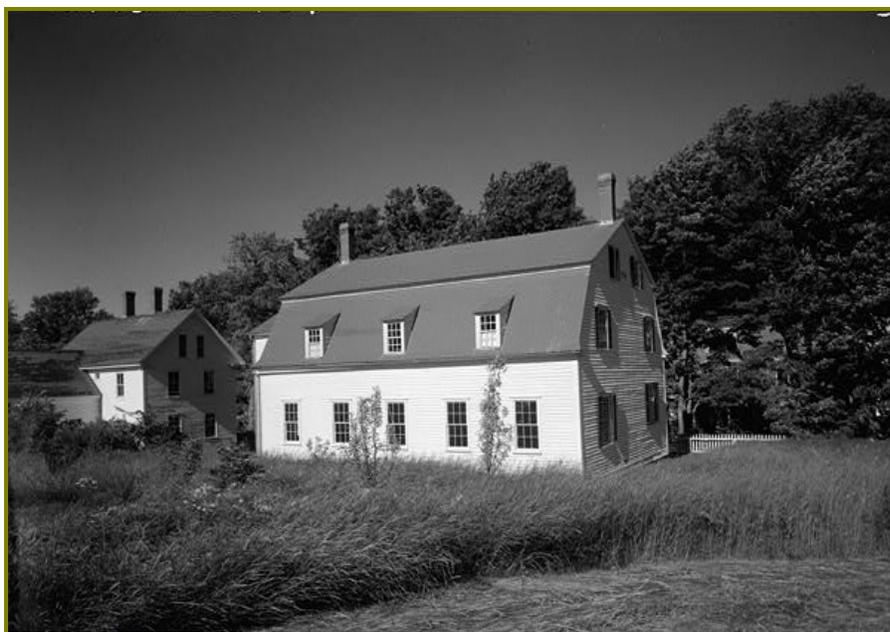
**Figure 19. Meeting house at Sabbathday Lake, Maine**  
Image courtesy of Library of Congress

Shaker architecture of the antebellum period (pre-1861) evolved over time. At first, Eastern Shakers favored an Anglo-Dutch style harking back to Colonial times. Gambrel-roofed buildings were common, such as the ca. 1794 meeting house at Sabbathday Lake, Maine (Figure 19). Later Shakers employed a simple Federal style, with side-gabled roofs, plain exteriors, and symmetrical window and door openings. Some Shaker builders stayed with this plain Federal vernacular long after the outside world turned to more ornate Victorian styles; however, if we look closely at Shaker buildings, we'll find influences of contemporary architectural trends and regional vernacular building styles and types.

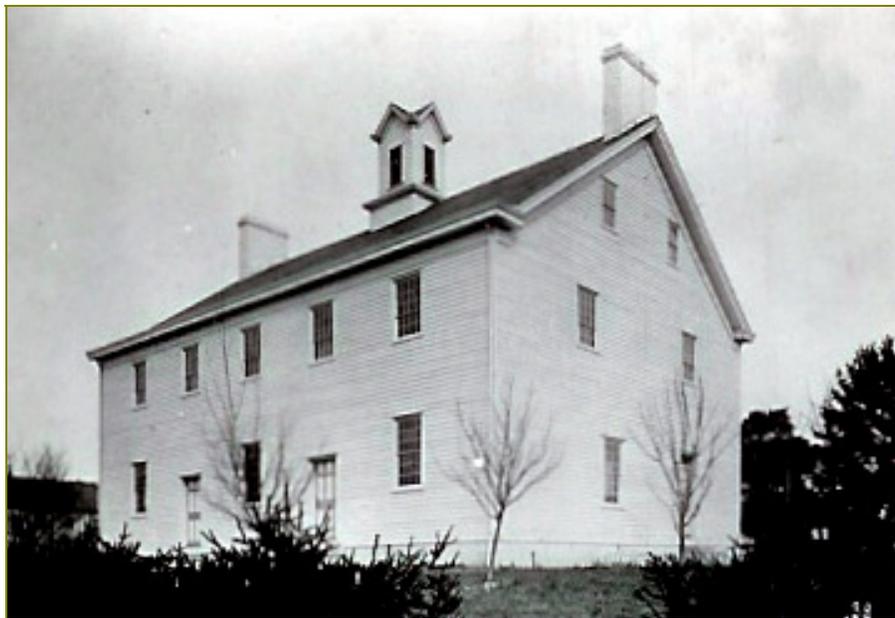
**Figure 20. Union Village meeting house**  
Image courtesy of Otterbein Homes Museum & Library

The pre-Civil War Western Shaker vernacular features broad roof gables and horizontal proportions. The style's most striking feature is the use of small, short, boxy windows, widely spaced, producing large expanses of plain wall. The Union Village Meeting house was a good example of this style, built in 1806 (Figure 20). This conservative tendency provided each building with plenty of solid structure, and fewer and smaller windows may have also made the buildings cheaper and faster to build. It is not clear where this style originated, but it echoes early nineteenth-century vernacular traditions. Eastern Shakers may have brought this vernacular style to Ohio, influenced by late eighteenth and early nineteenth-century New England timber-frame residences, or these features might also derive from the ca. 1805–1820 Kentucky and Ohio frontier aesthetic. Design on the frontier retained early vernacular and Late Georgian characteristics, and the small, widely spaced windows of log cabins may have also influenced the style.

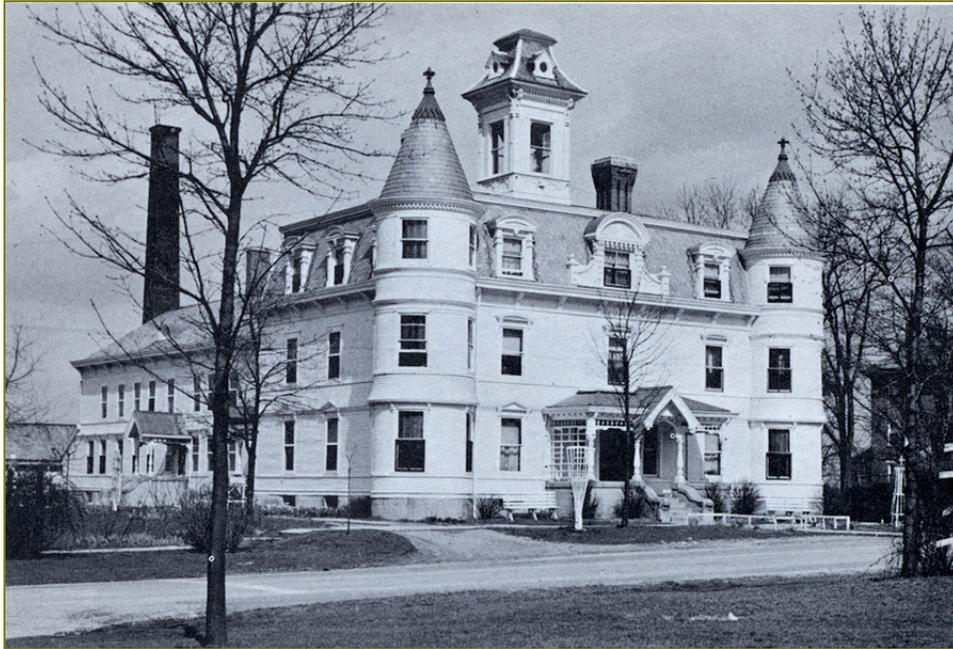
**Figure 23. Center Family Office after remodeling**  
Image courtesy of Otterbein Homes Museum & Library

The only example of lavish post-Civil War design at Union Village is the still-extant Church Family Office, now known as Marble Hall. This frame building started out as a typically plain Shaker vernacular building (Figure 22), but under the direction of Union Village trustee and first elder Joseph Slingerland, it was remodeled in the early 1890s with elaborate Eastlake trim, corner turrets, and a Mansard roof (Figure 23). The apparent intent of the renovations was to attract new members to Union Village, by showing off the communal wealth of the society and emphasizing the modernity of the society, which at the end of the nineteenth century had relaxed many of the stricter behavioral rules and was allowing more freedom to individual members. However, the architectural renovations and the attempts to found new Shaker communities in Georgia failed to attract substantial numbers of new converts to keep Union Village viable. Slingerland was removed as head elder at Union Village in 1902 under a cloud of allegations of financial mismanagement. To Slingerland, the Victorian style of Marble Hall represented Shaker modernity. Today, the building represents to some a period of decline, in which Western Shaker values were diluted by acceptance of

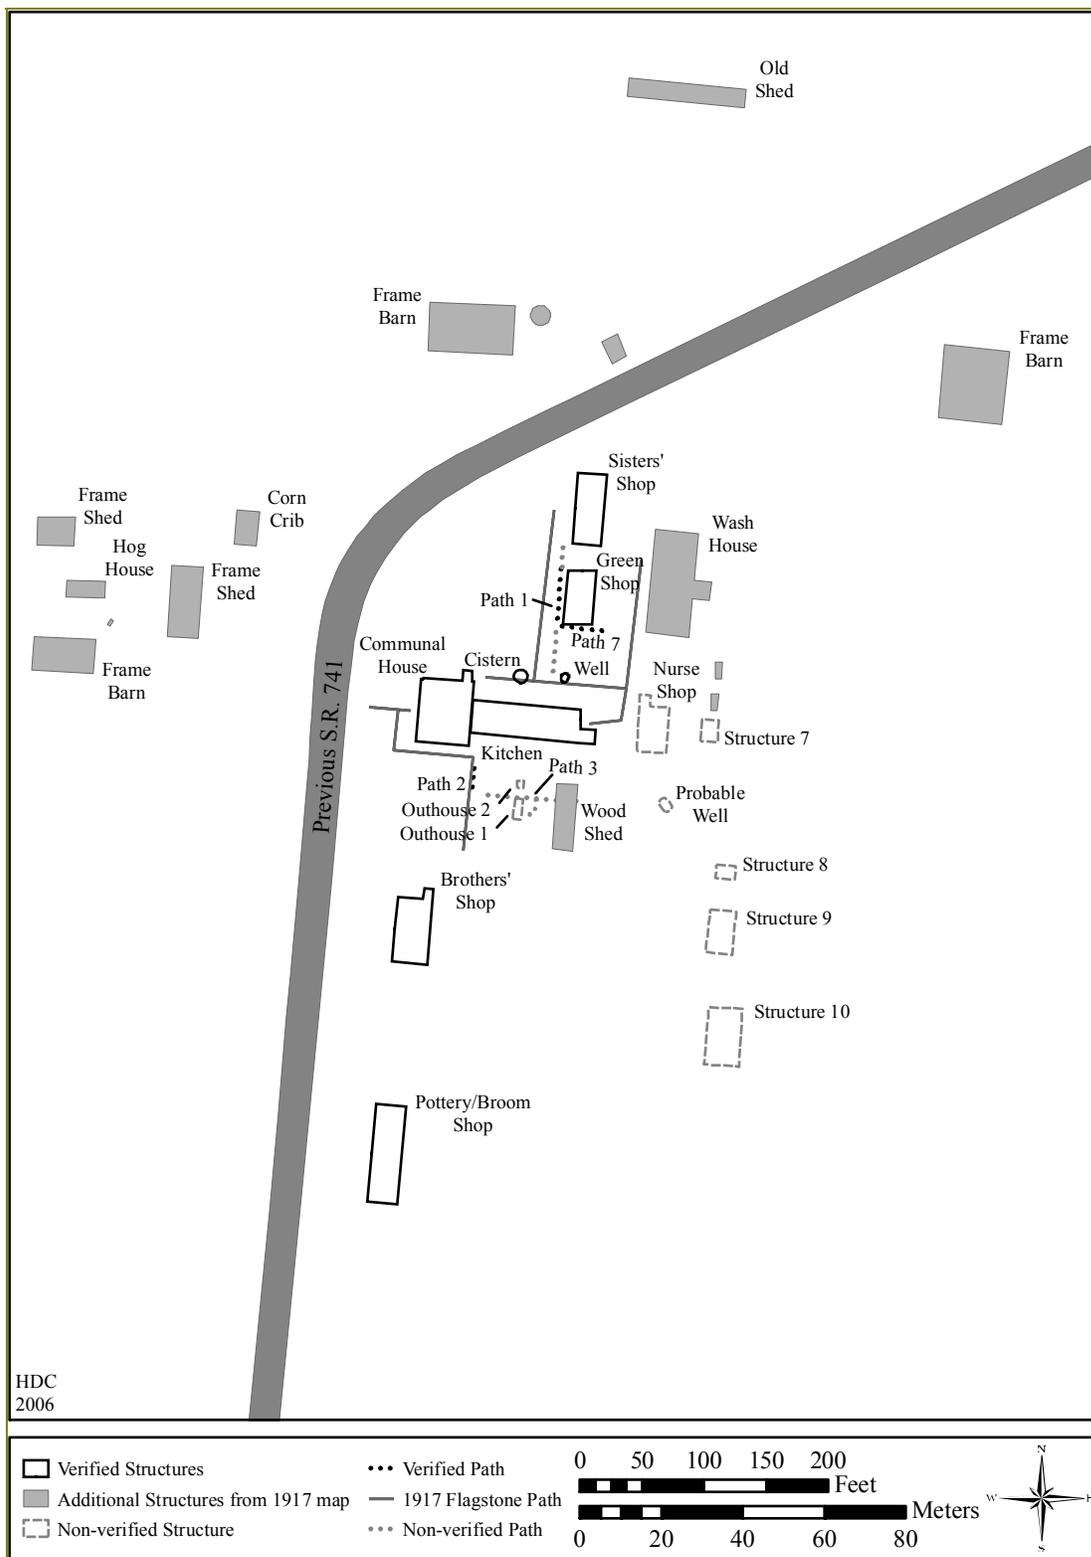
Figure 26. Overview map of North Family Lot, showing verified locations of buildings and other landscape features

- Black dashed line—paths verified through archaeology
- Gray dashed line—paths indicated through geophysical testing
- Solid gray line—paths shown on the 1917 survey map but not found through either archaeology or geophysics

The locations of the structures that were on the 1917 map but were not tested through archaeology or geophysics are most likely not in the exact physical locations, especially those further out from the main group of residential buildings. This probable discrepancy is due to the process of matching the 1917 map to the actual locations of excavated buildings, which resulted in a warping of distant buildings. The warped buildings were corrected to more closely approximate the appearance of the 1917 map, but actual physical testing will be required to verify their locations.

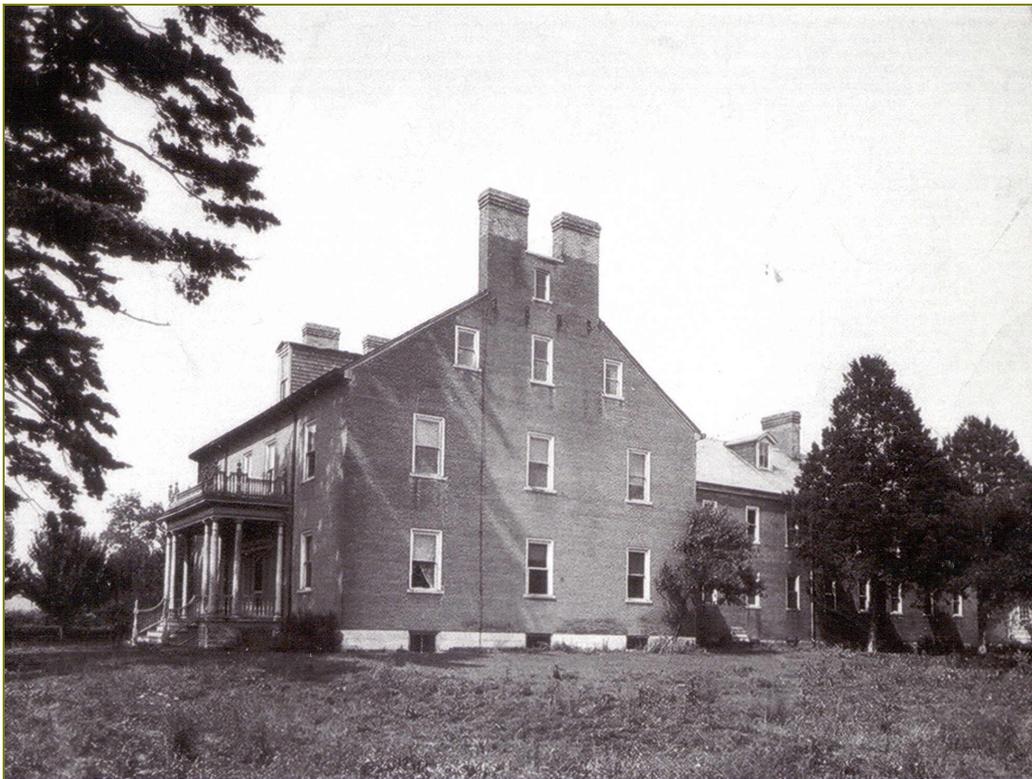
**Figure 27. Main Dwelling House at the North Family Lot, ca. 1915**  
(Otterbein Homes 1915)

The house was a side-gabled, four-bay house, stylistically a plain example of the Federal style. A photograph included in a 1915 United Brethren Church newsletter shows four bays on the front of the building, with two windows inserted in the former location of the twin central doors, and a new single doorway in between the former door locations (Figure 27). The porch is a late nineteenth-century Shaker addition, probably installed about the same time as the Center Family Office underwent its renovation into a Victorian-style building. A single roof dormer was present on the front façade of the building. The side elevations of the house had three windows per floor: large windows on the first and second floor, three smaller windows on the attic floor, and a small window at the apex of the roof gable. On both side walls were double brick chimneys with corbelled tops. The roof had a slight overhang. No cornices or other decorative features are visible on the exterior of the house. At Pleasant Hill, Kentucky, several side-gabled dwellings of this type featured arched fanlight transoms and other Adamesque details; however, the plain style represented in the North Family Lot Communal House at Union Village is more typical of Shaker domestic design of the era.

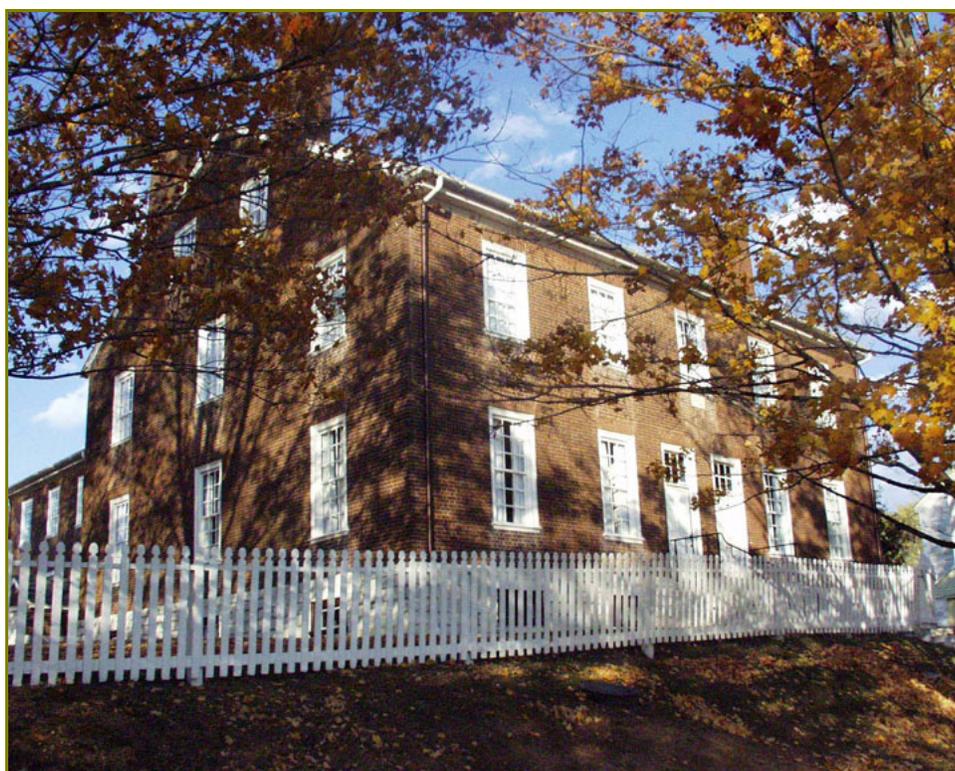
Figure 28. West Family communal dwelling at Pleasant Hill

In some ways, the exterior form of the North Lot Family communal house is similar to the second West Family dwelling at Pleasant Hill, Kentucky (Figure 28). The Kentucky structure is a side-gabled brick house with three-bay side elevations and double chimneys on the side walls, although with a shorter rear kitchen ell. The West Family dwelling at Pleasant Hill was also constructed from 1821 to 1822, so it is contemporary with the North Family Lot communal dwelling at Union Village.

influenced some Shaker builders of the 1815–1860 period. A quick look at the tall, large windows of the West Farm Dwelling at Pleasant Hill, Kentucky, (see Figure 28 on page 53) shows the Federal influence on Western Shakers.

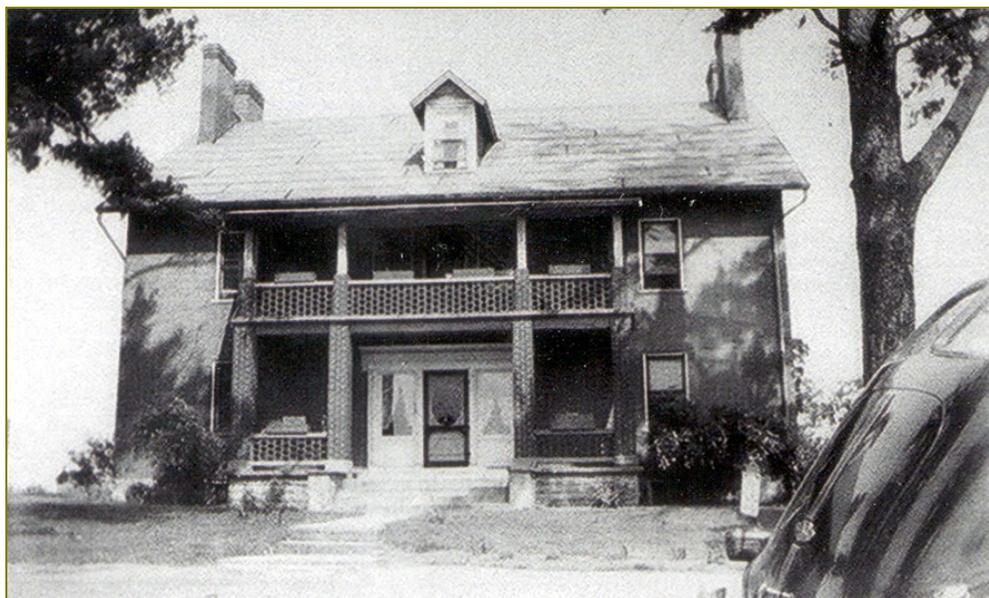
**Figure 30. Communal House, ca. 1940**  
Image courtesy of Otterbein Homes Museum & Library

Renovations continued during the Otterbein Homes period. Several proposals were made between 1919 and 1924 to expand the Good Samaritan facility by building an attachment between the Kitchen and the Sisters' Shop, but these never came to fruition. Records from the 1920s indicate that the building's heating boiler was replaced sometime between 1926 and 1927. The house was re-roofed and new gutters were installed in 1937, and new wood floors were installed in several locations in the building in 1945, along with new dining room lighting fixtures. The first porch placed on the building was replaced sometime before the 1940s with a newer porch (Figure 30). Plans also surfaced from this time to move the Good Samaritan

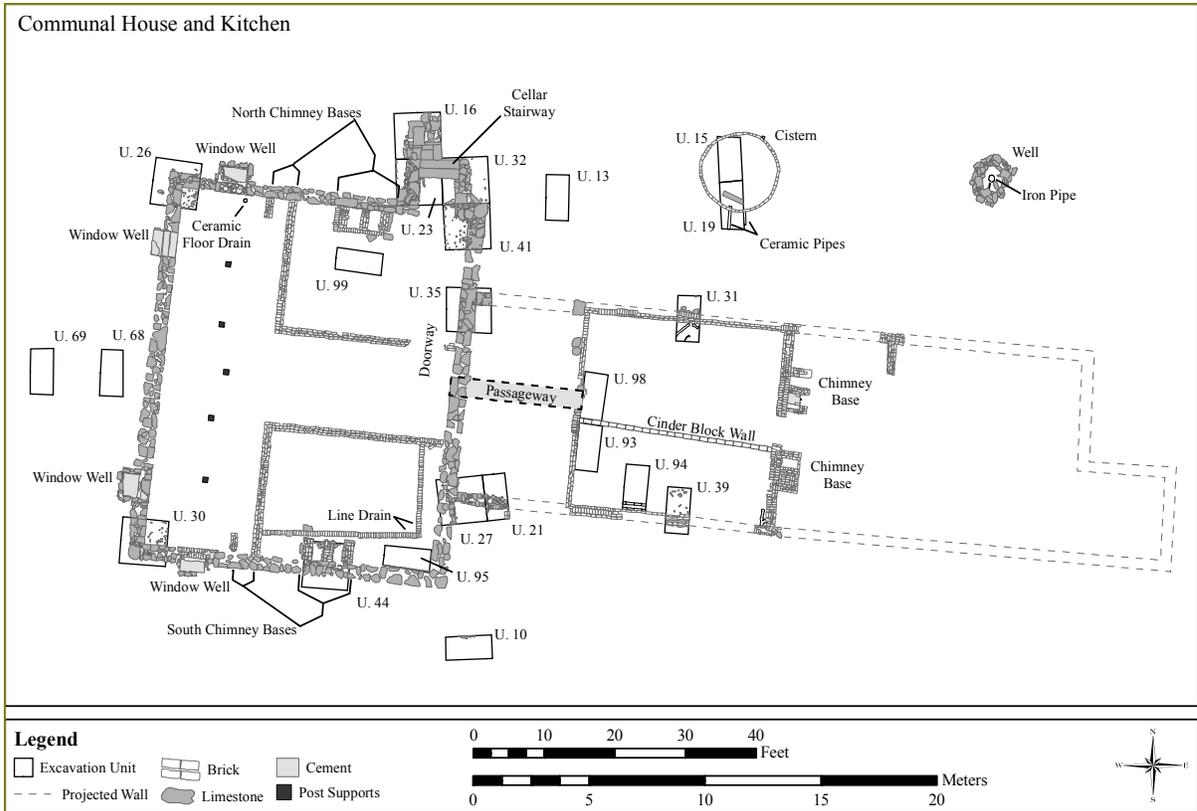
Figure 31. Communal House/Kitchen foundations, as excavated

A combination of hand-dug excavation units and heavy machinery was used to examine the Communal House and Kitchen (Figure 31, Figure 32). The units allowed the archaeologists to assess the condition of the foundation and to guide the removal of the demolition debris in the cellar by a backhoe. After all of the fill was removed from the Communal House and the portion of the Kitchen within the project right-of-way, we were able to observe numerous details about the construction and use of the buildings. The Kitchen was excavated in two phases of fieldwork: the western end during the main fieldwork session in the spring of 2005, and a portion of the middle of the Kitchen during the June 2005 fieldwork.

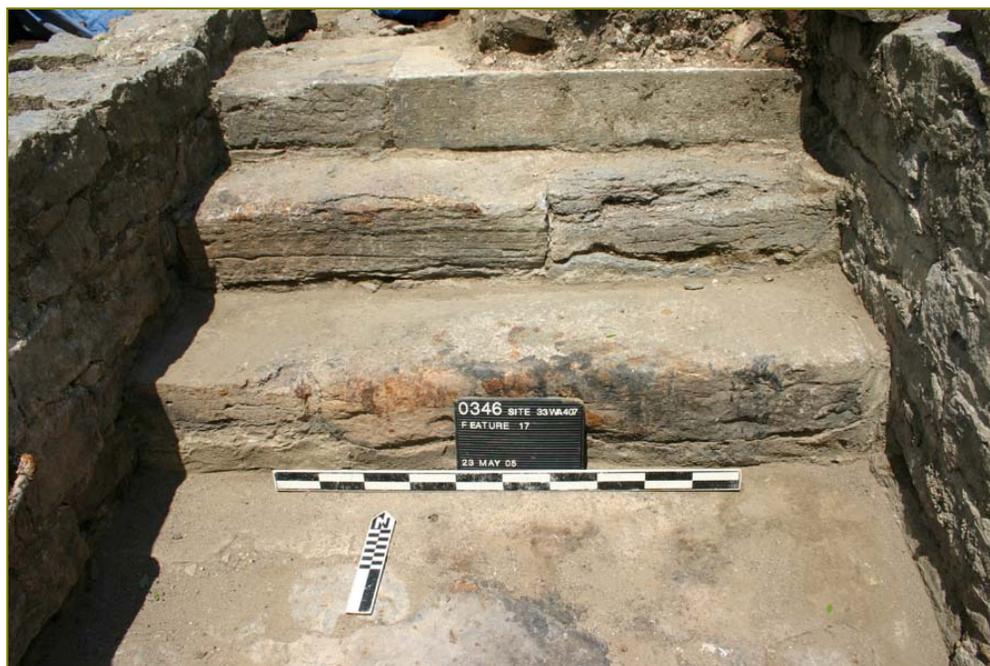
The cellar entrance was fairly well preserved; only the upper portions are missing. Three steps made from massive stone blocks were still present when the cellar was excavated (Figure 33). The northern end of the entry was fairly disturbed, and it is likely that one or more steps were originally present at that location. The interior width of the cellar entrance was 5 feet, 3 inches. The cellar entrance projected 8.5 feet out from the main foundation. An electrical conduit pipe was installed through the south wall of the cellar entrance, likely one of numerous twentieth-century renovations. The floor at the bottom of the cellar entrance stairwell was poured concrete.

**Figure 33. Cellar steps, facing north**

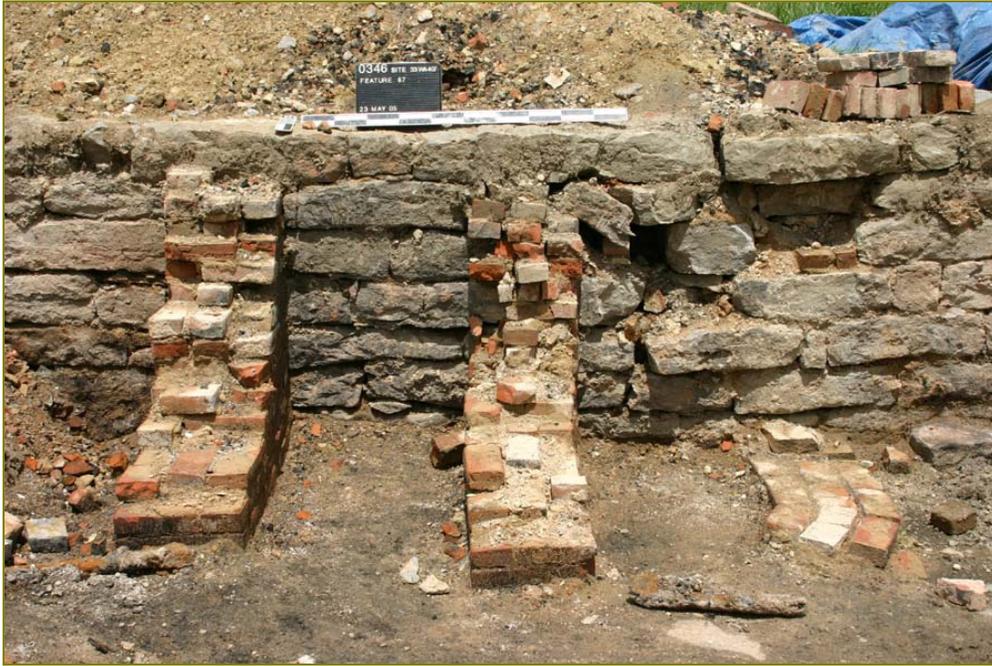
Figure 34. Northern set of eastern chimney piers, Communal House

The northern pier was slightly larger, and also much less intact. The entire chimney measured 80 inches wide and extended out 37 inches from the foundation wall. Each individual pier was 12 inches wide. The spaces between the piers measured 21 inches. Due to damage from the demolition of the structure, original heights for the piers could not be determined. The actual heights of the piers as recorded during excavation were as follows: west pier, 36 inches; middle pier, 35 inches; east pier, 5 inches. The brick foundation that partially enclosed this set of chimney piers consisted of a single course of bricks, set side to side and 7 inches wide. This brick foundation was present on the west and south sides of the chimney.

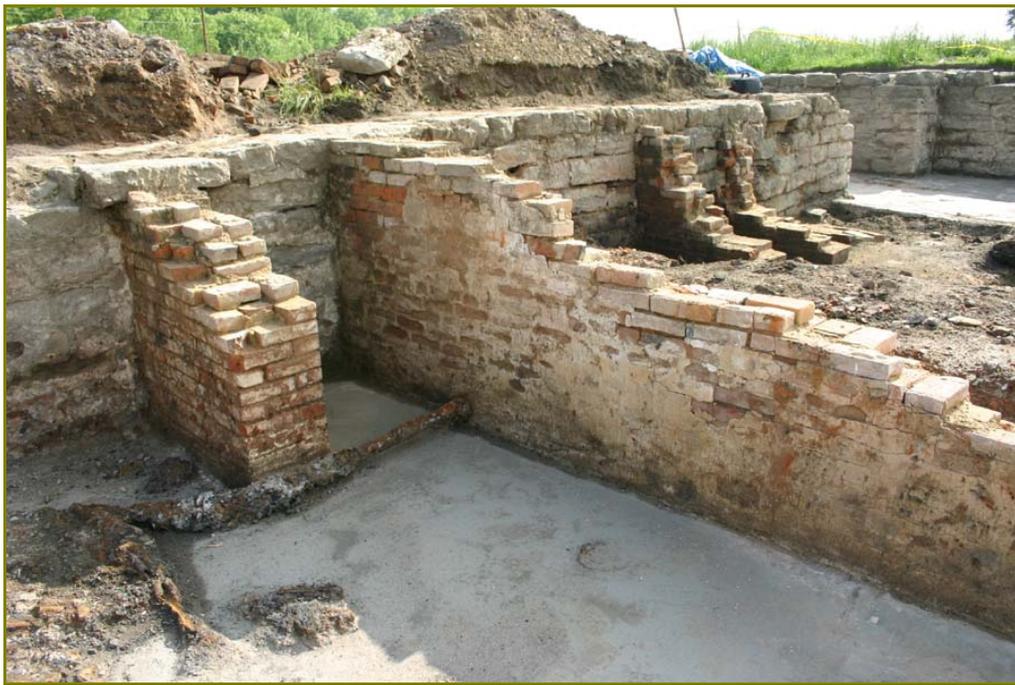
Figure 36. Northern cellar room wall and north solitary pier, Communal House

The eastern chimney base locations were set apart from the rest of the basement in separate rooms, built with brick walls set in common bond. These walls were butt-joined against the stone foundation and not built into the wall, indicating that they were built after the stone foundation was completed. The northern room's wall extended 19 feet south from the north foundation wall and turned 90 degrees to the east, where it extended another 24 feet to the location of a doorway in the wall (Figure 36). The doorway was indicated by a break in the brick wall, with unbroken cement flooring in place. The doorway was 4 feet wide and was aligned with the cellar entrance. The wall continued on the east side of the doorway another 4 feet, 6 inches to join the eastern foundation.

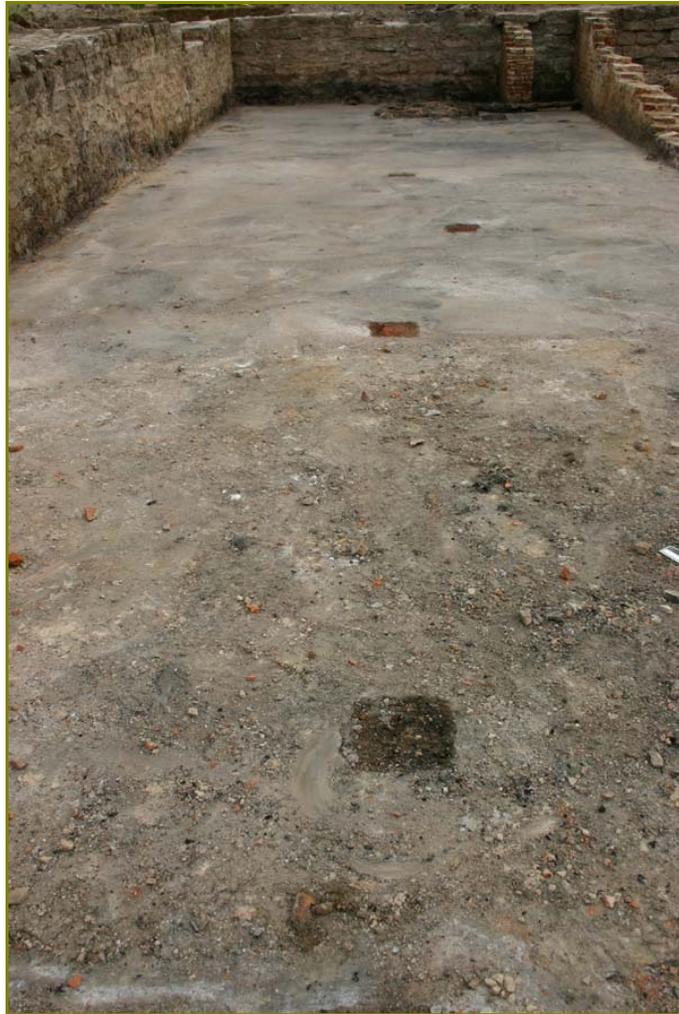
Figure 40. Series of posts in Communal House Cellar, facing north

A series of five brick post supports were found in the front section of the cellar (Figure 40). The centermost post was slightly offset from the main line of posts, about 8 inches to the east. The post supports each consisted of two hand-made bricks set side by side in the floor, and the square posts would have measured approximately 8 to 9 inches square. Although bricks were present as bases, we do not know if the posts themselves were wood or brick.

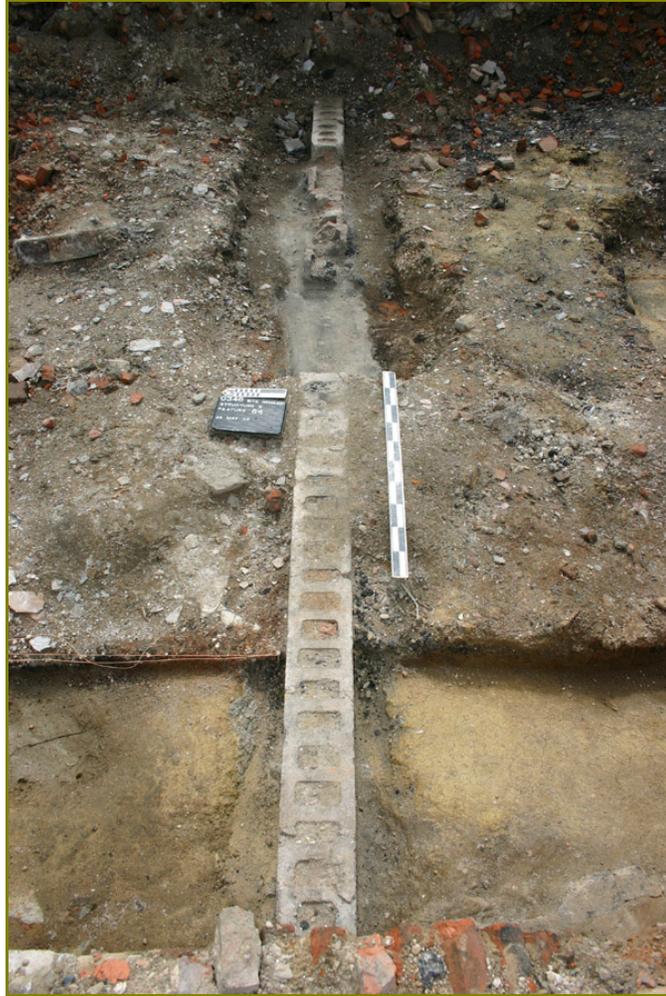
**Figure 41. Cinder-block wall in Kitchen cellar**

The cinder-block walls were discovered during separate phases of excavation and given separate feature numbers, but it is probable that the portions of the walls excavated represent the same cinder-block wall. This wall or set of walls was located in the south half of the cellar and was built with two sizes of cinder blocks, one block size measuring 8 inches by 16 inches with three holes, and the other block size measuring 8 inches square with one hole. The cinder-block holes measured 3 inches square. The width of both walls was only one course of block. The cinder-block wall in the western portion of the cellar excavation extended 6.5 feet from the west wall to the location of a doorway, and continued into the eastern limit of the excavation at that time. This cinder-block wall had only one course of cinder blocks still intact. The wall sat on top of the cement floor (Figure 41). The cinder-block wall found during the second phase of excavation at the Kitchen extended east from the south chimney base for 33 inches to the limit of that excavation (Feature 104). This cinder-block wall was intact to a height of 28 inches, the same level as the chimney base. If the two cinder-block walls were actually sections of the same wall, they would have enclosed an interior room in the basement roughly 12 feet wide and 28 feet long.

The use of cinder blocks dates the construction of the room to no earlier than the early 1900s, when the blocks became more common in use. Interestingly, the wall was not built exactly parallel with the long axis of the structure but instead was built with each end terminating just south of an entranceway, resulting in a slightly skewed appearance in plan view.

The passageway entrance between the Communal House and Kitchen cellars was present in the west wall, and was lined with cinder blocks similar to those used in the cinder-block walls (one of which is visible in Figure 45 as the low gray wall in the lower left of the photograph). This entrance cut through the earlier brick arch and measured 35 inches wide. We believe that this passageway was built during the Otterbein Homes occupation, as no mention of what would have been a significant renovation to the Communal House and Kitchen was located in any of the Shaker journals and diaries that we consulted for this project.

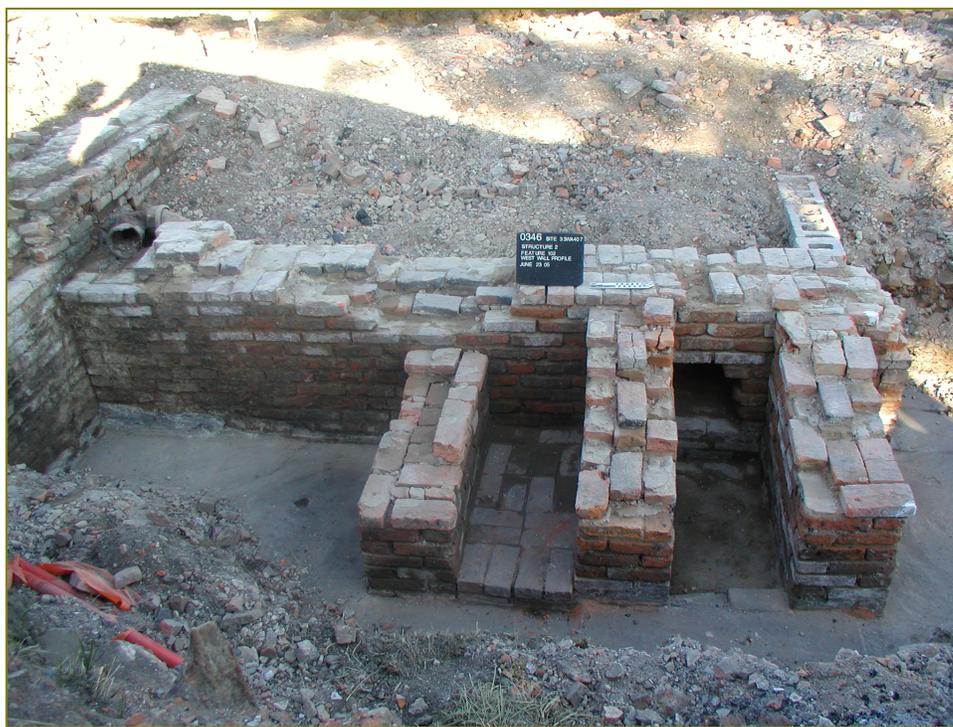
Figure 42. Southern set of chimney boxes, Kitchen cellar

The center chimney bases were built into what is probably an interior structural wall with a doorway in the middle (Figure 42, Figure 43). Each chimney base consisted of a set of three brick piers, built against the east face of the wall. These chimneys originally had brick floors in between the piers, the only intact example of which was present in the space between the southern and middle chimney piers of the southern base. A cast-iron ash box was present in the northern chimney base between the southern and middle piers and resembles in form Shaker-produced, cast-iron stoves, although we are uncertain of the date it was installed (Figure 44). An iron pipe was set into the floor in front of the ash box door, which would have prevented the door from fully opening. The floor between the middle and northern piers was cemented over when the cement flooring was put in, which could also be when the pipe was installed at the ash box door. No floor at all was present between the middle and southern piers of the southern chimney base.

is unclear as to when it could have been in use. Most likely, the hole was not in use when the chimneys were active, and so may have first been used in the twentieth century after a switch to a more modern furnace system. The dimensions of the chimney bases as they were encountered are as follows: The wall of the southern base was built with the common bond brick pattern and at its most intact point was 1.5 feet thick and 2 feet, 10 inches tall. The wall was a total of 11 feet, 10 inches long from the southern foundation wall to the doorway between the chimney bases. Mortar impressions on the south foundation wall of the Kitchen show that the wall was originally at least as tall as the existing foundation, and we can reasonably assume that the wall extended from the floor to the ceiling in its original state. The first chimney box for the southern base, consisting of the southern and middle piers, was located 5 feet, 2 inches north of the southern foundation wall. The second chimney box, consisting of the middle and northern pier, was located 9 inches south from the central doorway. The maximum height of the most intact chimney pier was 31 inches. Each chimney base pier measured 3 feet long by 13 inches wide, and had an interior width of 1 foot, 5 inches between piers. Each pier was set on a small limestone foundation.

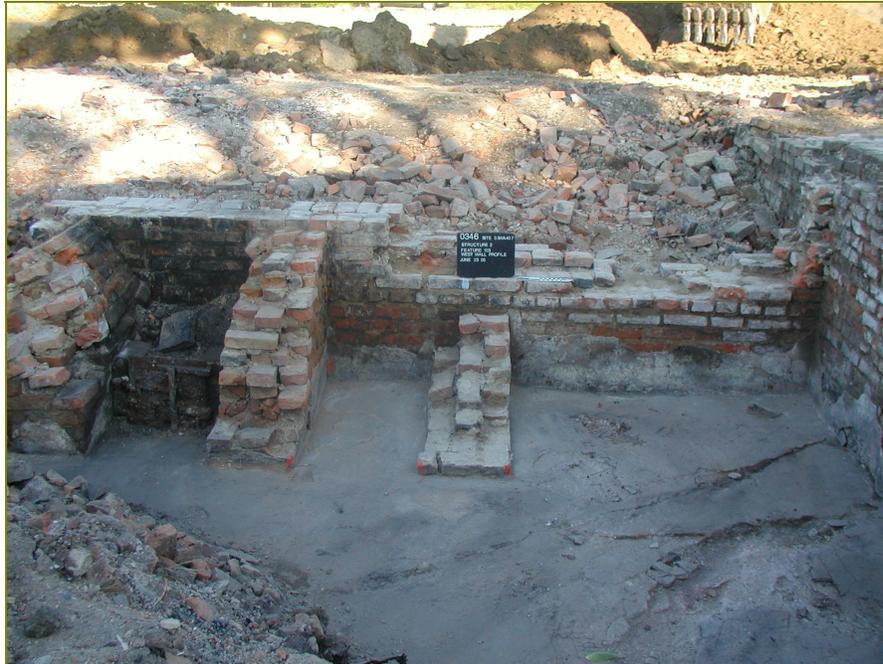
Figure 43. Northern set of chimney boxes, Kitchen cellar

The northern chimney base was similar but not a mirror image of the southern chimney base. The northern chimney base had the same dimensions for the chimney boxes and chimney piers, and the wall was the same width. The distance between the northern chimney pier and the northern Kitchen foundation wall was 4 feet, 10 inches, slightly shorter than the distance between the first chimney pier and the foundation on the southern chimney base. The total length of the wall the chimney bases were set against was 12 feet long, slightly longer than the southern wall. The doorway between the chimney bases was 43 inches wide.

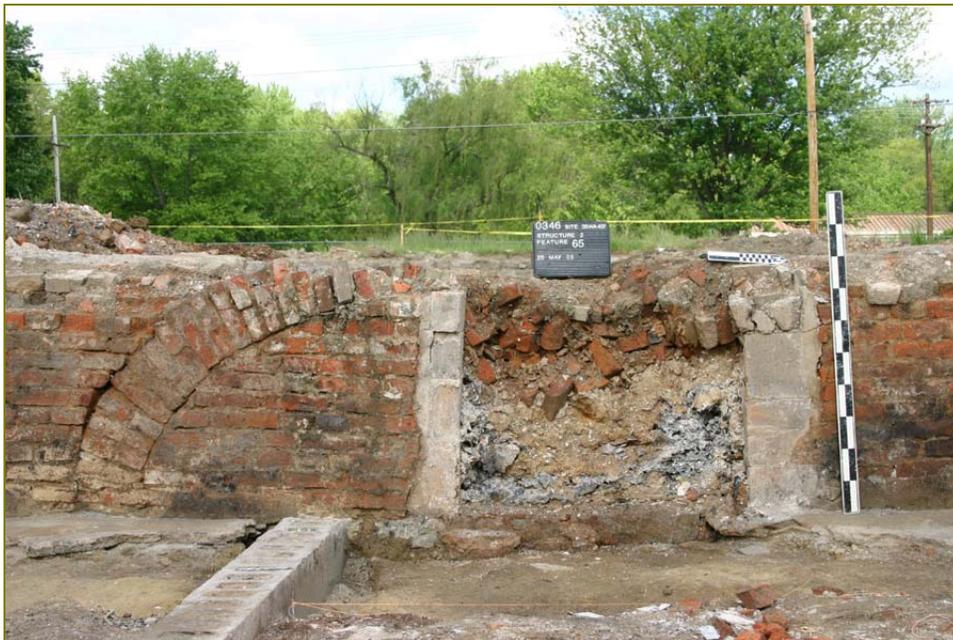
**Figure 45. Brick arch and passageway entrance in west wall of Kitchen cellar**

The west wall of the cellar had a partially intact brick arch built into it (Figure 45). The purpose of arches such as these, built into walls, is usually to distribute the load of the building over an open space, such as an interior cistern. An architectural engineer examined this arch during a field visit and determined that the arch was likely abandoned as a functioning part of the structure while the building was under construction, and was bricked up before the structure was completed. The partial arch was 4 feet, 10 inches long and 2.5 feet tall. By projecting the continuation of the arc of the arch on the west wall of the Kitchen cellar, we determined that the original intact arch would have had an exterior length of 83 inches and an interior width of 69 inches. The reason for the presence of this arch is unclear, as no sign of a subfloor cavity was found in the arch location. We did find a fragment of an anonymous letter to Matthew Houston dated April 20, 1829, discussing the North Lot Family's finances and mentioning that the design of the Kitchen had to be scaled back from a budget of \$5,000 to a budget of \$2,500. The arch may have been a component of the original design that was abandoned as contributing too much debt to the project.

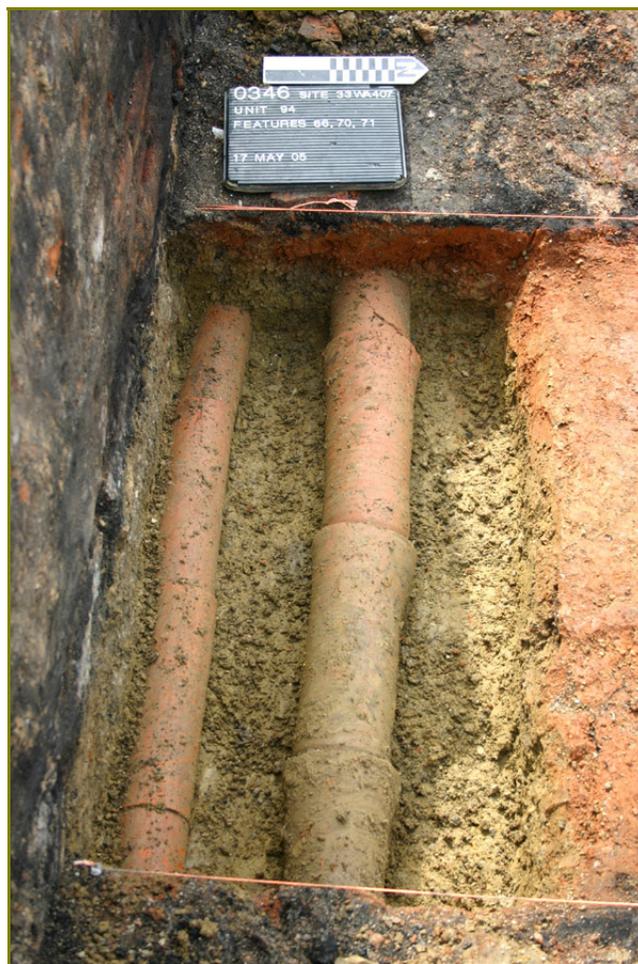
Figure 46. Shaker-made water pipes in Kitchen cellar

pottery located at the North Family Lot. Two different types of pipe were used, one type for each drain line. The piping present closest to the south foundation wall was made from cylindrical pipes laid end to end. Each individual section of piping was a straight cylinder, with no tapering or flaring present at either end, and measured 12 inches long with a 4-inch diameter. The piping set to the north of the first set of pipes consisted of pipes made to join together with “male” and “female” ends. Each pipe measured 14 inches long; the female or flared end was 5.5 inches in diameter and 0.75 inch thick, and the male or tapered end was 3.75 inches in diameter and 0.5 inch thick. Both sets of pipes were set in the same excavated trench and may have been installed at the same time (Figure 46).

The pipes could be the new piping mentioned in the North Lot Family diary entry for September 2, 1846. The dual set of pipes may indicate that each pipe was connected to a separate source of wastewater and may have had separate outlet points as well. A twentieth-century iron water pipe was present entering the cellar on the west side of the chimney wall on the south end, and likely was attached to a utility line identified in the geophysical survey in this general location.

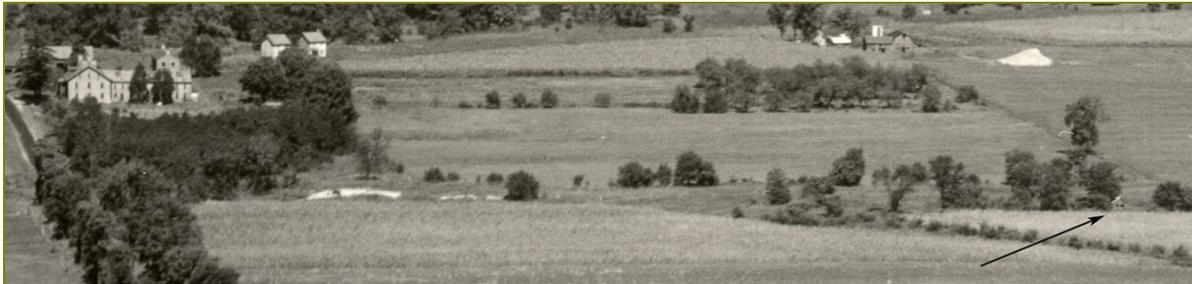
Figure 47. Detail of ca. 1930s aerial photograph

The demolition or removal date of the building is unknown, but may predate 1917, as no building is shown south of the Pottery/Broom Shop on the 1917 Otterbein Homes survey map. However, close examination of the 1930s-era aerial photograph of Otterbein Homes shows a small, one-story frame building located southeast of the North Family Lot that may be this

structure (Figure 47). This building does not show up on any twentieth-century maps, though, so it is uncertain whether this building actually represents a Shaker building that was simply overlooked by surveyors due to its out-of-the-way location, or a twentieth-century building constructed by tenant farmers.

Arrow in the lower right corner points to a small frame building southeast of the main building cluster of the North Family Lot. Enlargement shown at right.

Two one-story log buildings are on the 1835 map that might be good candidates for the Morris House, although they are not wood-frame houses and are located to the east and northeast of the communal dwelling. A building labeled the “Garden House” on the 1835 map may also represent the Morris House. The latest related entry in the known documentary record for this building is a reference in the anonymous North Family Lot diary to the relocation of the Morris House to east of the garden on October 6, 1837. This entry tends to discount any of these three buildings as possible candidates (Union Village Diarist 1836–1857:371). A fourth unidentified building is present south of the Brothers’ Shop on the 1835 map, but its form suggests it was not a house. The North Lot Family diarist reported that the Morris House was moved to a location east of the garden on October 6, 1837 (Union Village Diarist 1836–1857:371). Based on the 1829 map’s placement of the garden to the east of the communal dwelling, the Morris House would be far to the east of the communal dwelling and the cluster of shops that surrounded it, possibly in the location of a small cluster of farm buildings that was present east of the North Family Lot up to the 1940s (now the location of the runway for a local radio-controlled model airplane club). This cluster of farm buildings is visible in the upper right portion of Figure 47.

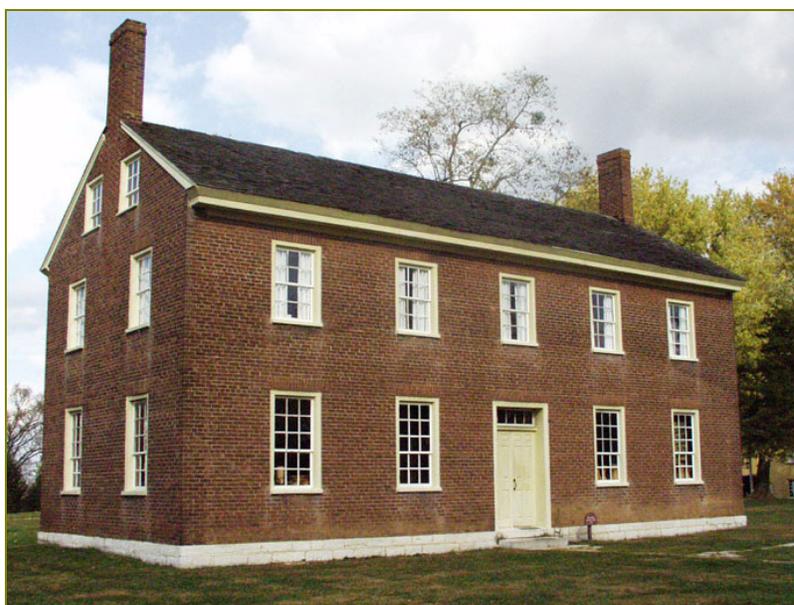
**Figure 48. East Family Brethren's Shop, Pleasant Hill, Kentucky**  
(Photo by Roy Hampton, October 2005)

No archival photographs were found depicting this building. Miller's 1835 record of buildings at the North Family Lot states that the building measured 30 feet by 55 feet. Diary references to the building in the 1840s indicate that it had a basement used for craft industries. Representations of the exterior features on the 1829 map of Union Village and the 1835 maps of the North Family Lot appear to be somewhat schematic in their representation of the building and may not reflect the actual features of the Brothers' Shop as it existed at the time. Both maps show a two-story, side-gabled, brick building with chimneys at each of the gable ends. The 1829 map shows a building only three bays wide, while the 1835 map represents it as a five-bay structure. Given the 55-foot width reported for the original building, and the typical window and bay dimensions of brick buildings at Union Village, it appears the five-bay configuration is the more likely of the two representations. The Brothers' Shop probably closely resembled the East Family Brethren's Shop at Pleasant Hill, Kentucky, which was also a two-story, five-bay, brick shop building (Figure 48).

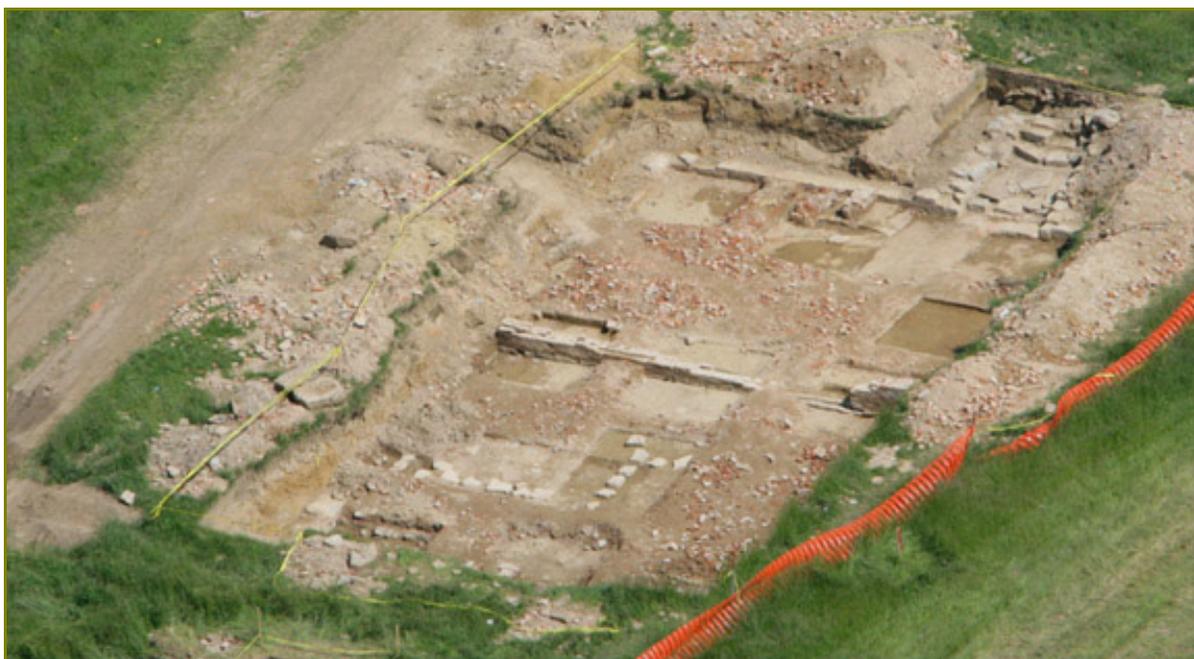
**Figure 50. Aerial photograph of excavated Brothers' Shop facing northwest, showing missing foundation**
