# ENCOUNTERING THE SHAKERS OF THE NORTH FAMILY LOT, UNION VILLAGE, OHIO

## *A Clean and Lively Appearance — Landscape and Architecture of the North Family Lot*

VOLUME 2 OF A 4-VOLUME MONOGRAPH SERIES

January 30, 2009

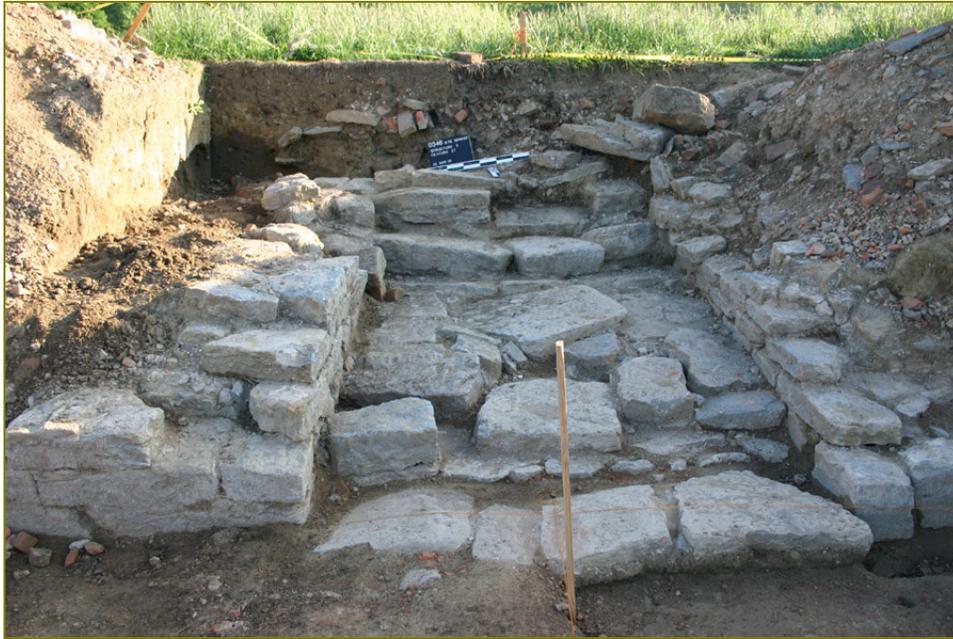
The cellar entrance was as extensively salvaged as the foundation, and it is difficult to determine how many steps may have been present. As excavated, there were two apparent steps present at the north end of the entrance (Figure 51). The entrance itself measured 11 feet, 2 inches long, with an exterior width of 8 feet and an interior width of 5 feet, 2 inches. The apparent steps began at the north end and ended 7 feet from the south end of the entrance. The top of the highest remaining step was at 26 inches below modern ground surface. The depth of this step and the rather short length of the steps within the entrance suggest that the steps may be only the remnants of a larger set of steps that extended further into the cellar entrance.

**Figure 51. Cellar entrance, Brothers' Shop**

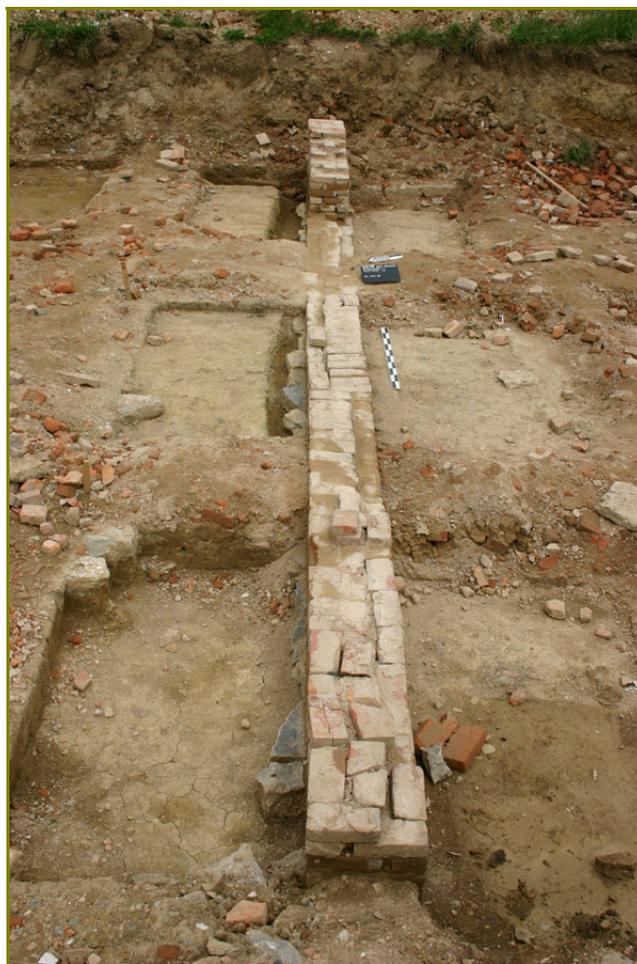
**Figure 52. Central wall in Brothers' Shop cellar, facing east**

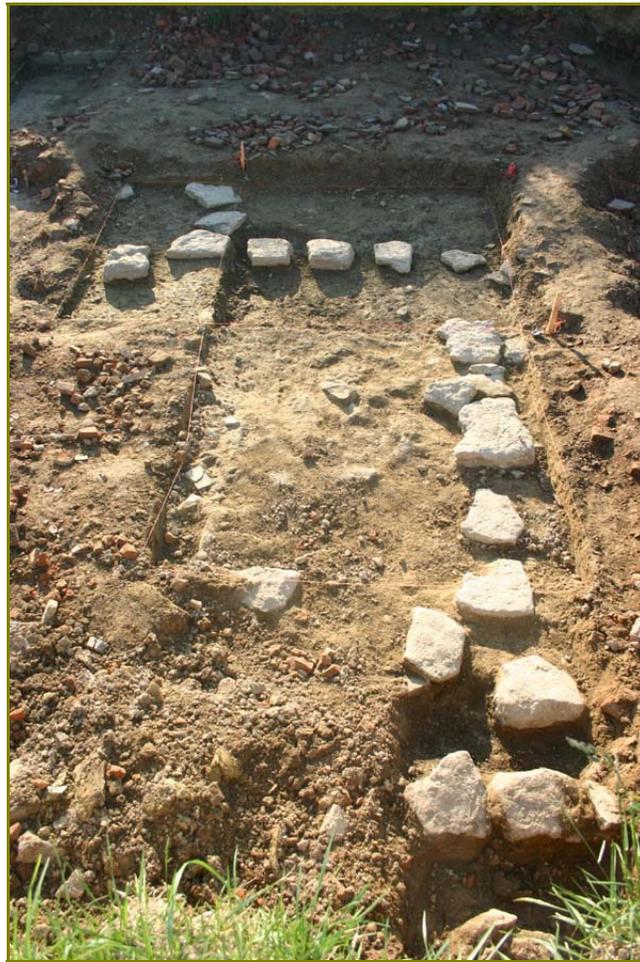
A stone alignment found in the southern half of the cellar might have supported a floor. The alignment consisted of a central north-south line of rough-hewn limestone blocks, with secondary lines of limestone blocks extending to the west on the south end of the central line and to the east on the north end of the alignment (Figure 53). The alignment was not completely intact, and stones were missing. The alignment may have served as floor supports for the rooms in the southern half of the cellar, with the central line also serving as an interior frame wall support. We assume that the central wall originally extended from the interior brick wall south to the chimney base, but no stones associated with the alignment were found in either of the excavation units to the north and south of the intact alignment.

The total length of the central line of stones as excavated was 7.5 feet. The western secondary line of stones was mostly intact in length and measured 16 feet, 5 inches long. The eastern secondary line of stones was only 20 inches long. The width of the alignment was hard to determine precisely, due to variations in the individual width of the stones in the alignment, but they seemed approximately 12 inches wide in most places.

**Figure 53. Stone alignment in south half of Brothers' Shop cellar, facing east**

An entry dated May 5, 1840, in the North Lot Family diary noted that “James Darrow and Timothy Bonnel are working in the brick shop cellar making two rooms in the south end” (Union Village Diarist 1836–1857:373); it is almost certain that the stone alignment was part of this construction event. These rooms were finished on June 1, 1840 (Union Village Diarist 1836–1857:375).

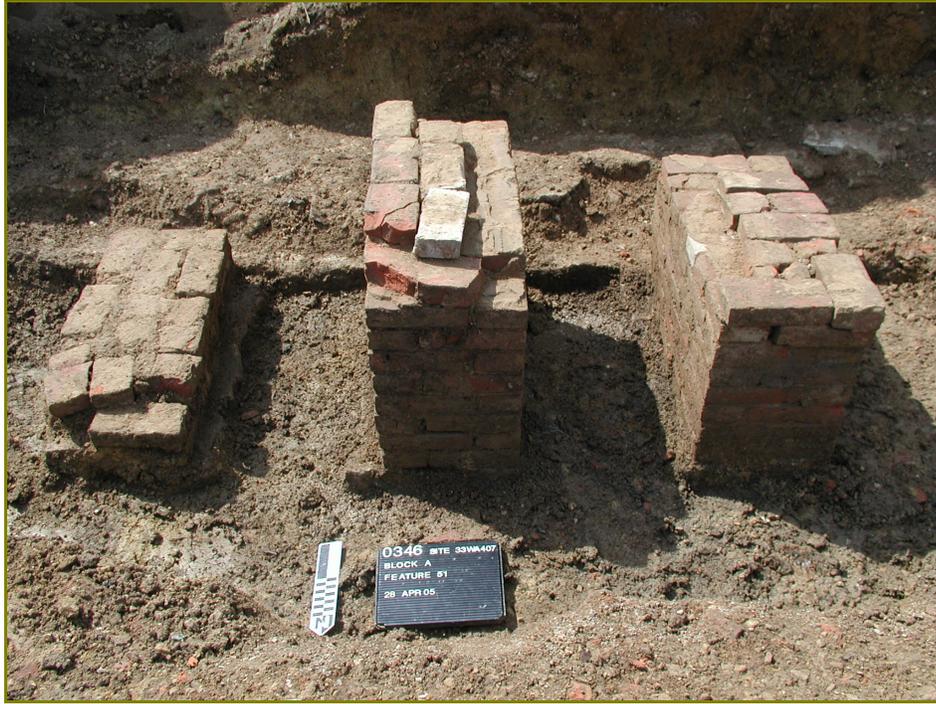
Two chimney bases were constructed on the north and south sides of the structure, each consisting of a set of three brick piers set on stone footers. The southern chimney base was the more intact of the two bases (Figure 54). The piers were set on limestone footers and placed with 17-inch-wide gaps between the piers. The piers each measured 30 inches long by 13 inches wide. The piers had been affected by the demolition of the structure and were of varying height when uncovered. The west pier was 19 inches tall, the center pier 24 inches, and the east pier 9 inches. The entire chimney base was 61 inches wide.

**Figure 54. Southern chimney base, Brothers' Shop**

While similar in basic construction and plan to the Communal House and Kitchen chimney bases, the chimney bases in the Brothers' Shop had different dimensions. The overall width of the chimney bases was 10 inches shorter than the chimney bases at the Communal House, and the space between piers was 3 inches shorter. Interestingly, the piers themselves were 1 to 2 inches wider, but 3 to 7 inches shorter in length. The Kitchen chimney bases had more similarities to the chimneys at the Brothers' Shop, having the same pier widths of 13 inches and the same space between piers at 17 inches, but they were slightly wider as a whole at 63 inches, and they projected further from the wall at 36 inches.

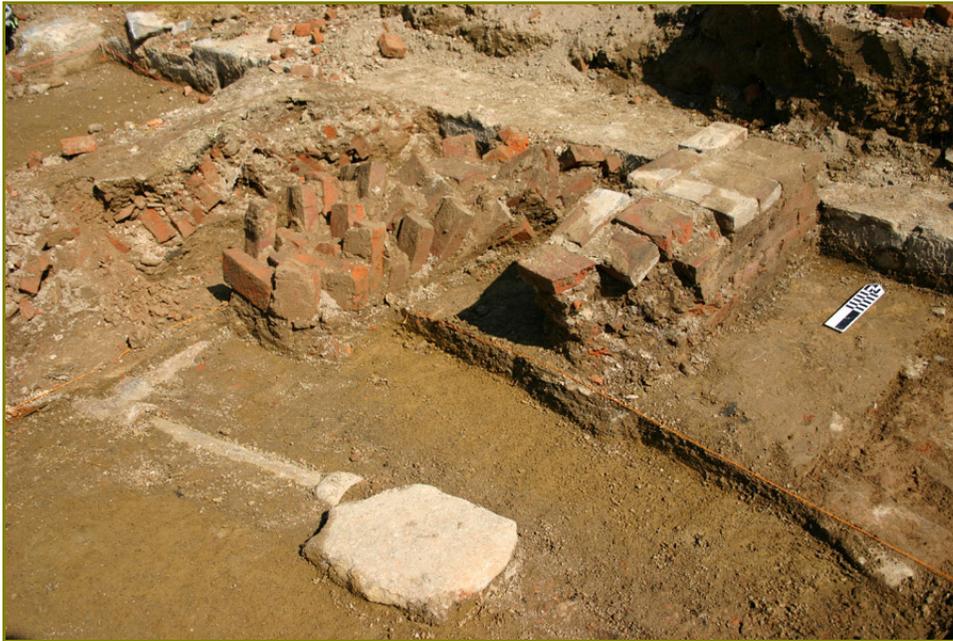
The northern chimney base was in much worse condition when uncovered (Figure 55). Only the center pier had intact bricks, set in five courses to a height of 12 inches. The eastern pier consisted only of a limestone base, and the west pier had collapsed to the southwest. Like the southern base, the northern chimney base piers were also each 13 inches wide and 30 inches long, placed 16 to 17 inches apart. The total width of the chimney base is difficult to determine accurately because of the collapsed west pier, but it seemed to be between 69 and 77 inches wide.

Figure 55. Northern chimney base, Brothers' Shop

A later, mass-produced ceramic drainpipe was present in front of the north chimney base, likely a late-nineteenth-century addition (see Figure 55, lower left corner). This pipe had a flat limestone block at its eastern end, which may have supported some sort of drain cover set into a raised wood plank floor (if one was present). The entire length of this drain was not uncovered, but a second pipe segment joined the first one and angled southwest, with another pipe joined to it at a 90-degree angle and heading northwest.

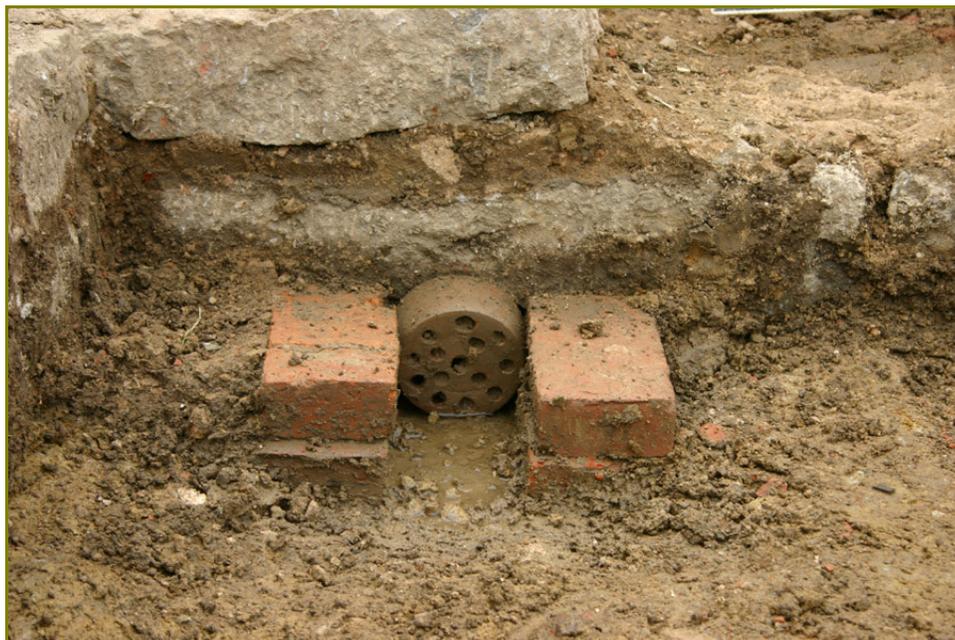
**Figure 56. Ceramic drain in southwest corner of Brothers' Shop**

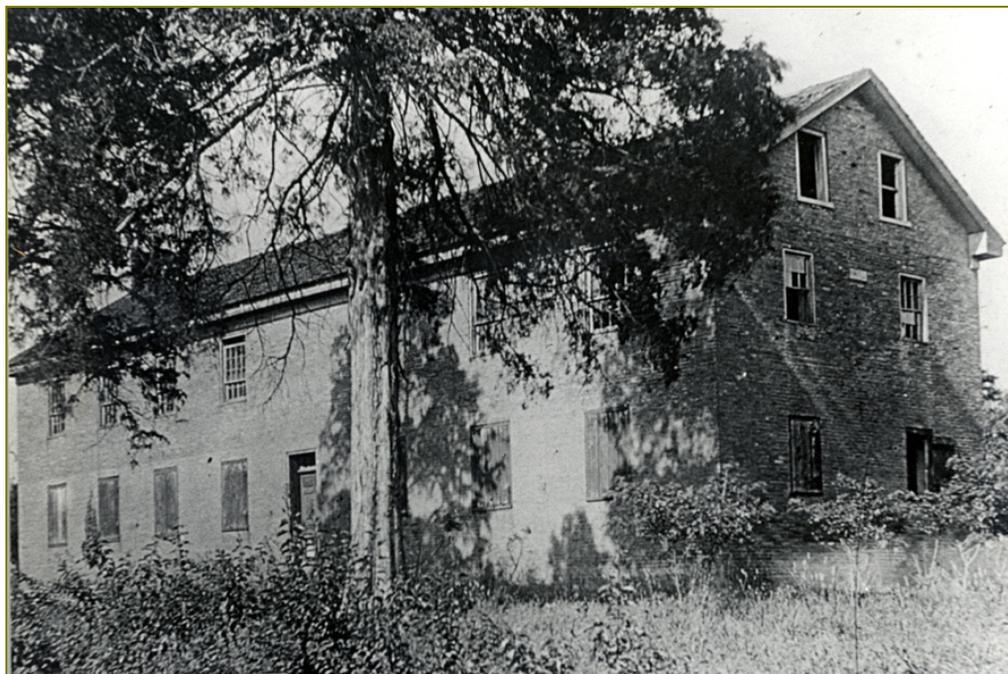
A ca. 1920 postcard of a building labeled as the “Former broom shop” is a photograph of this building (Figure 57), and it shows a side-gabled, two-story brick building with a low-pitched roof. Although partially obscured by a tree, seven windowed bays and a central wood door with a transom are visible on the long axis of the building. The short axis has two bays, with two windows on each of the full floors and two windows on the gabled attic level. The roof has a modest overhang, and the sills appear to be composed of brick. A small plaque visible on the short end of the building may have contained the construction date for the broom shop addition.

**Figure 57. Broom Shop, postcard photo ca. 1915**  
Image courtesy of Otterbein Homes Archive

The 1852 broom shop addition is indicated by the contrasting shade of the bricks between the first and second story in the photograph. However, the building shows no similar contrast between the original 1826 structure and the 1836 addition associated with the pottery, probably because the bricks used in the 1836 addition were made at Union Village, whereas the bricks for the 1852 renovation were obtained from an outside source that presumably used a different clay source for their manufacture. Admittedly, the tree in the foreground of the photograph obscures the point of the building where the 1826 shop and the 1836 addition meet, discouraging any comparison of the north and south portions of the building.

The visible examples of original windows in the photo appear to be twelve-over-eight, double-hung types with wood sashes. In the photo, most of the first-story windows have been boarded up or shuttered, and the side windows at the attic level appear to have been removed or smashed out. The second-story windows on the short axis of the building also appear to be in poor condition. The area around the building is overgrown. All of these features indicate that the building was vacant at the time of the photograph and may have been so for a long time before that.

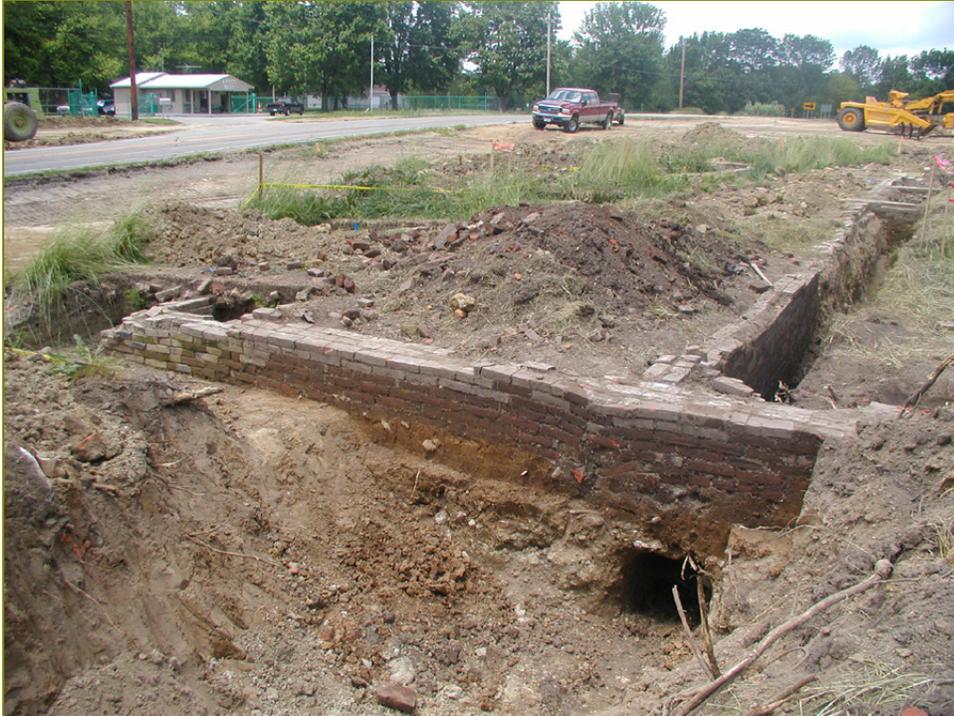
**Figure 59. Pottery/Broom Shop, southwest corner of original 1826 smith shop brick foundation, with June 2005 fiber optic tunnel**

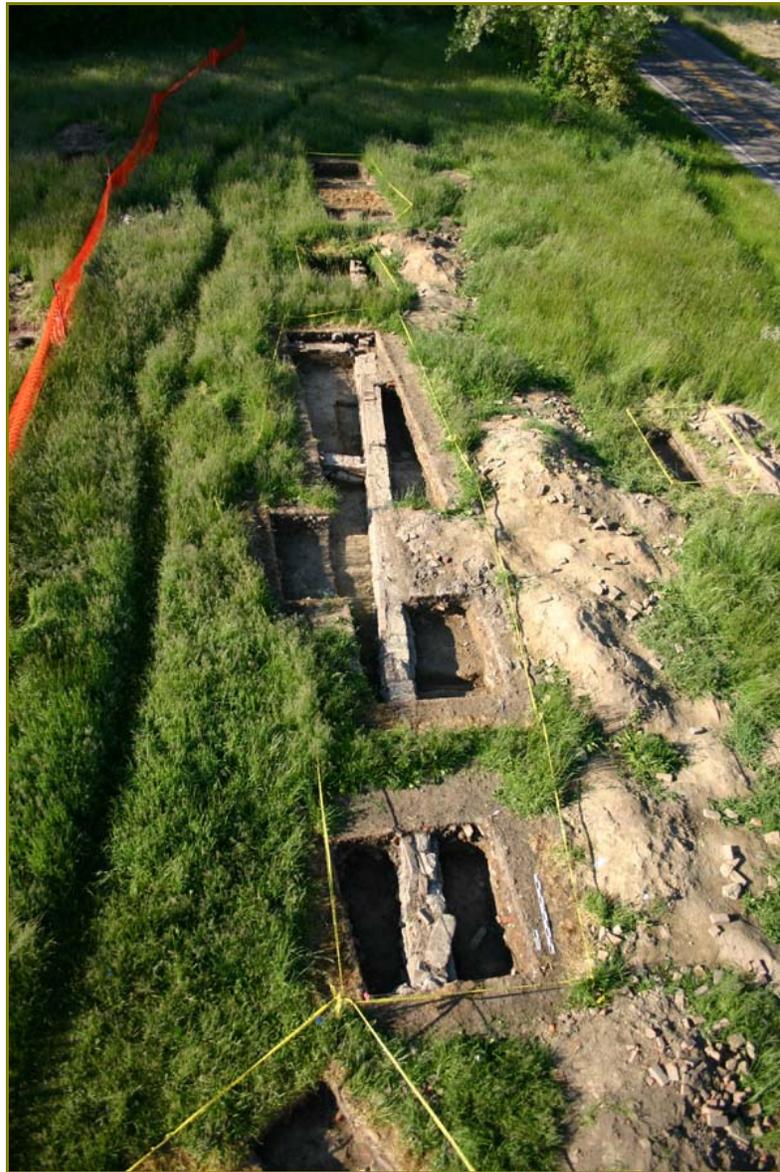
The building foundation was initially excavated by hand, using nine excavation units to expose structural details of the west foundation wall (Figure 58). In the June 2005 fieldwork session, archaeologists removed surface soil over selected parts of the foundation outside of the project right-of-way, using a Gradall excavator to expose part of the exterior face of the south wall while a fiber optic line was installed.

Figure 60. Pottery/Broom Shop western foundation, as exposed through unit excavations, facing south

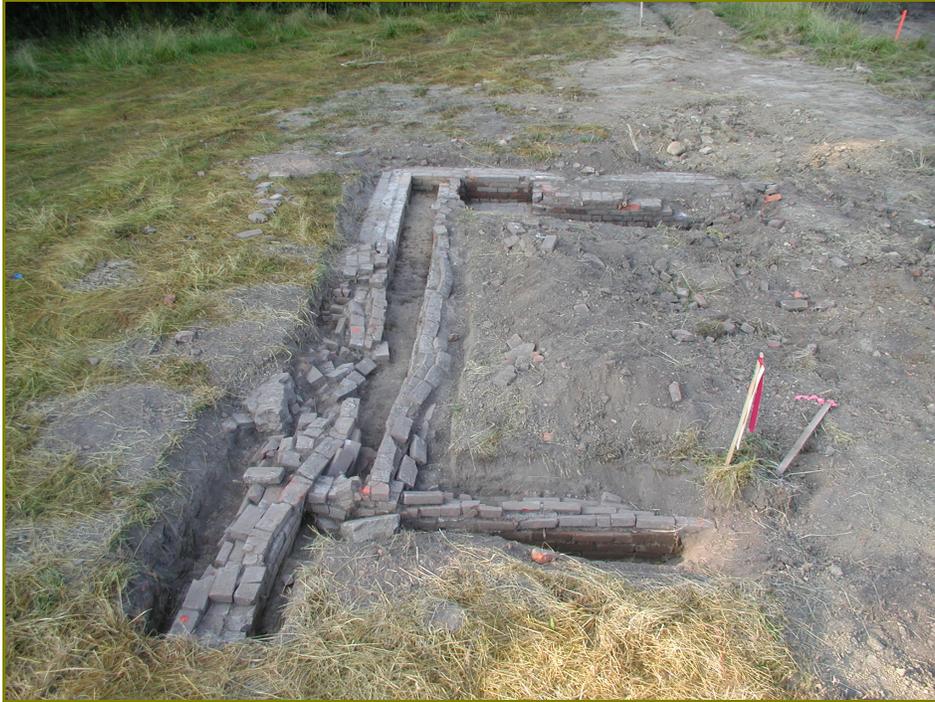
An interior support foundation of brick and stone was built along the long axis of the building, with a post base present in the center of the north half (the foundation is visible in Figure 59). A small cellar was excavated into the southeast corner of the building and had brick-lined walls (Figure 61). The cellar was likely a component of the pottery, used for storing raw clay. A possible brick stair support for a cellar entrance was also present in the southeast corner, and a possible chimney base was located on the south foundation wall, inside the cellar and west of the stair support.

**Figure 61. Pottery/Broom Shop cellar, June 2005 excavations**

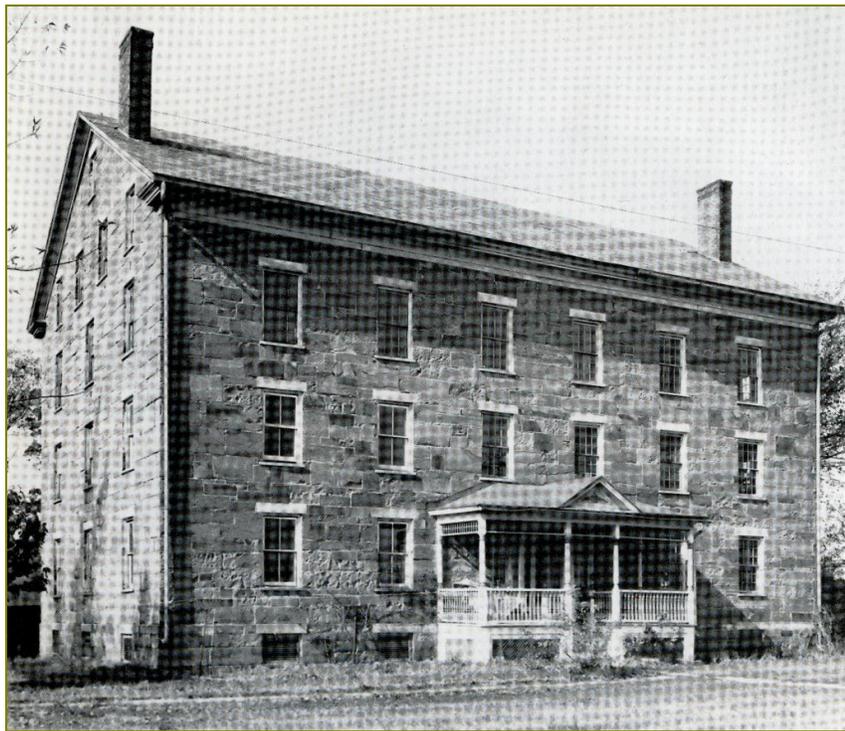
Figure 64. Ca. 1837 Sisters' Shop at Center Family, Watervliet, New York  
(Schiffer 1979:20)

While the buildings are similar in overall format, there are enough differences to suggest that they were not developed from a single standard set of plans and elevations. The roof pitch of the Watervliet building is higher, and window spacing for the buildings is different. The Union Village building is executed in brick, while the Watervliet building is constructed from massive blocks of stone. The Union Village building is also more conservative in terms of architectural style; it has low, broad proportions and wide, short windows that seem to hearken back to early New England Vernacular design, or possibly Ohio pioneer architecture, and it appears to stylistically match older buildings at Union Village. The longer, more narrow windows of the Watervliet shop building suggest some familiarity with high-style Federal design, or Early Victorian styles like Greek Revival or Italianate. The Watervliet Sisters' Shop also has a more elaborate molded cornice with returns, as opposed to the plain, flat cornice of the Union Village shop, again suggesting more influence of Victorian

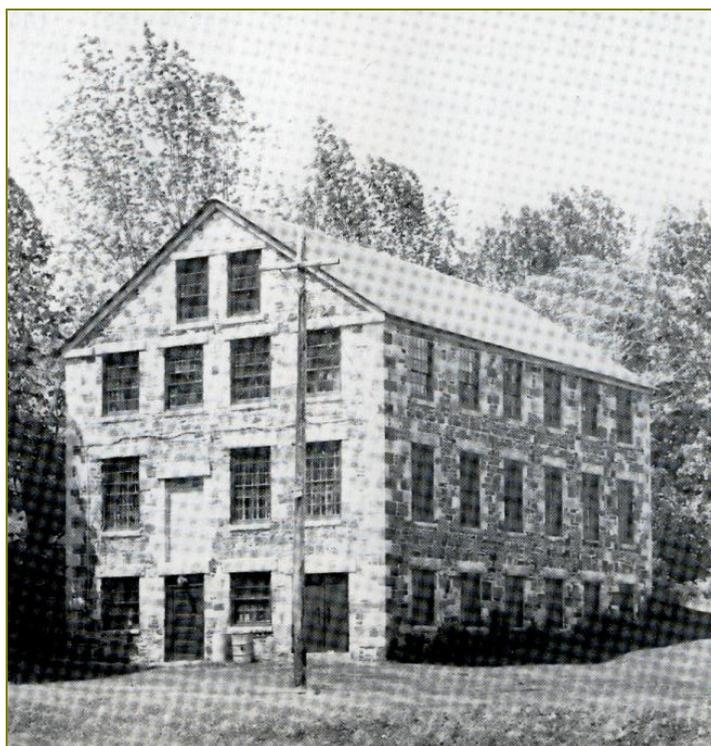
A second Shaker shop building was identified that is similar in appearance and format to the Sisters' Shop: the Church Family Machine Shop at Enfield, New Hampshire, dating to 1849 (Figure 65). In addition to reflecting older New England domestic vernacular styles, the large, squat windows of these buildings might also reflect an East Coast industrial vernacular design, in which functional mill buildings were constructed with maximum window space for lighting.

**Figure 65. Church Family Machine Shop at Enfield, New Hampshire (1849)**  
(Schiffer 1979:136)

However, the Union Village building still appears to have retained a sense of horizontal proportion that seems strikingly more of an early nineteenth-century vernacular form, even when compared to the Enfield Machine Shop. The reason for this is not clear but may have reflected conservative architectural taste at Union Village, the use of a very old set of plans to build the structure, or some desire on the part of North Family Lot leaders to blend the Sisters' Shop with the early major buildings of the lot that had been constructed ca. 1823–1827. Construction may have also been cheaper and quicker with fewer and smaller window openings, although the resulting loss of natural light would seem undesirable for a shop building. In constructing communal houses and other buildings, Union Village designers seem to have adhered to a conservative early nineteenth-century vernacular aesthetic long after it was abandoned by the outside world and even by many other Shaker communities.

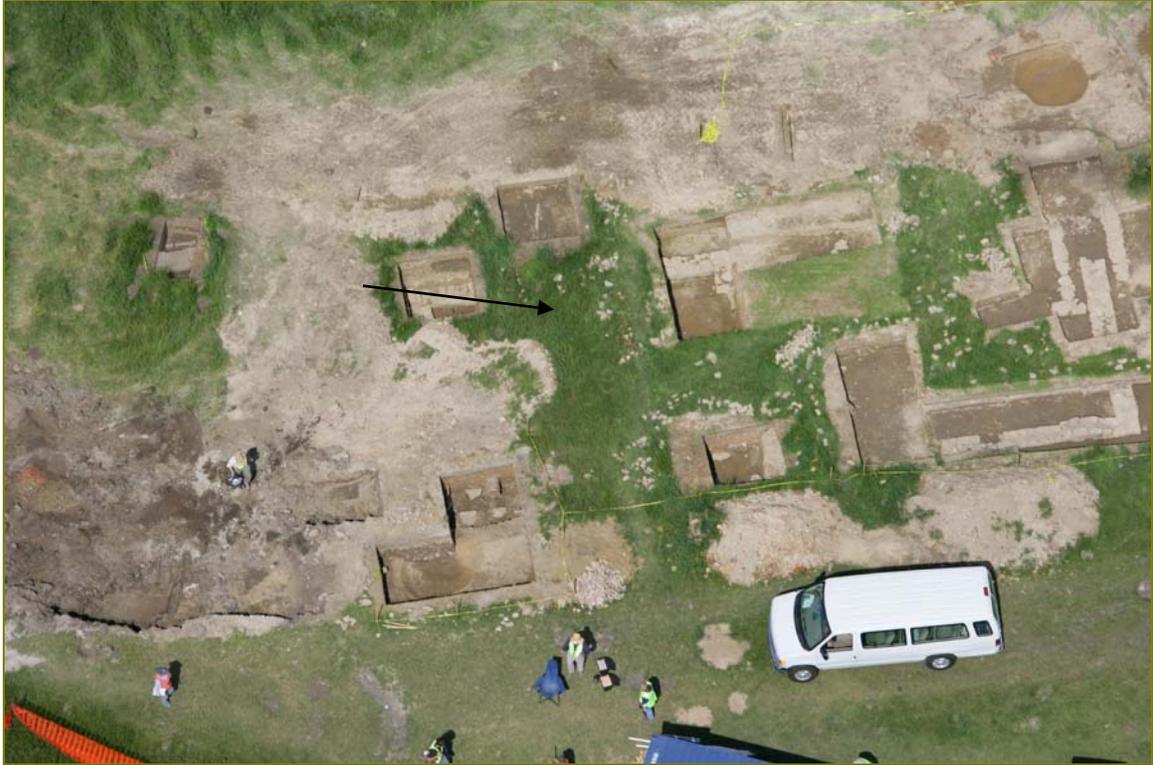
**Figure 68. Overview photograph of Sisters' Shop excavations, north at right of photograph**  
Cellar location indicated by arrow. Note the missing portions of the foundation.

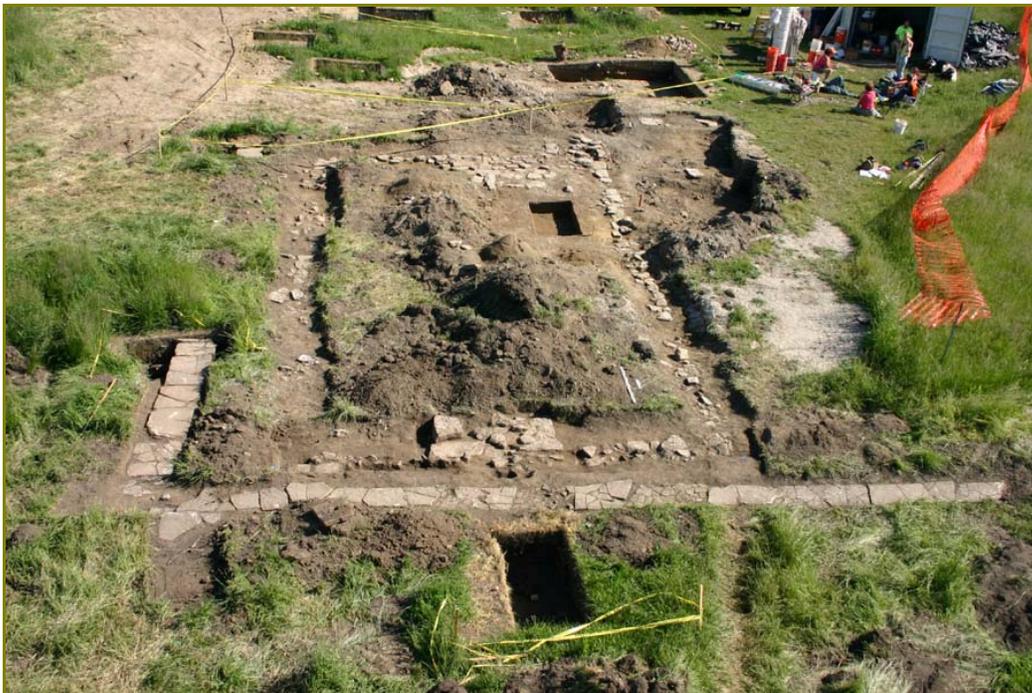
The foundation was very ephemeral, no more than a simple line of limestone cobbles, with limestone pads at the north and south ends that likely correspond to chimney bases (Figure 69, Figure 70). A base for a lightning rod was still in place at the southern chimney base. No evidence for a cellar was found during the excavations. A total of 223 artifacts were recovered from excavations of this structure. Curiously, this structure was the only one that yielded archaeological evidence of children: a porcelain doll arm, a porcelain toy teacup, and a tiny metal toy wrench. Interestingly, an entry in the North Lot Family diary recorded that the Second Family girls moved into the second floor of the Green Shop in 1840. These toys almost certainly belonged to some of the younger girls.

Figure 69. Green Shop foundation remnants facing north, with paths 1 and 7 in foreground

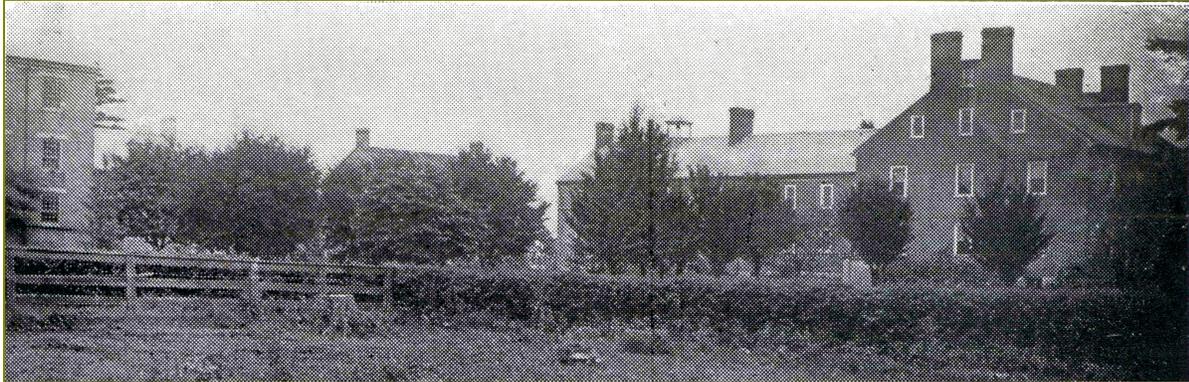
The Wash House appears in three photographs before Otterbein Homes divided it in two around 1918. The first photograph shows the North Family Lot in 1909, and was taken from the bend in the road, facing southeast (Figure 72). This photograph shows the Communal House and Sisters' Shop in the foreground, with the roofs of the Wash House and Nurses Shop visible in the background, partly obscured by small trees in the yard space north of the Communal House.

**Figure 72. View of the North Family Lot in 1909, facing southeast**

From left to right: Sisters' Shop, Wash house (chimney and roof visible immediately to right of Sisters' Shop), Nurse Shop, Kitchen, and Communal House. Image courtesy of Otterbein Homes Museum & Library.

correlating pollen/phytolith signature in the samples sent for analysis (Figure 72). Although the area was identified as a former garden, the results of the pollen/phytolith analysis cast doubt on this idea; however, the lack of evidence for the possible fruit trees in the 1909 photograph suggests that the pollen/phytolith records may have been somehow compromised in the last century.

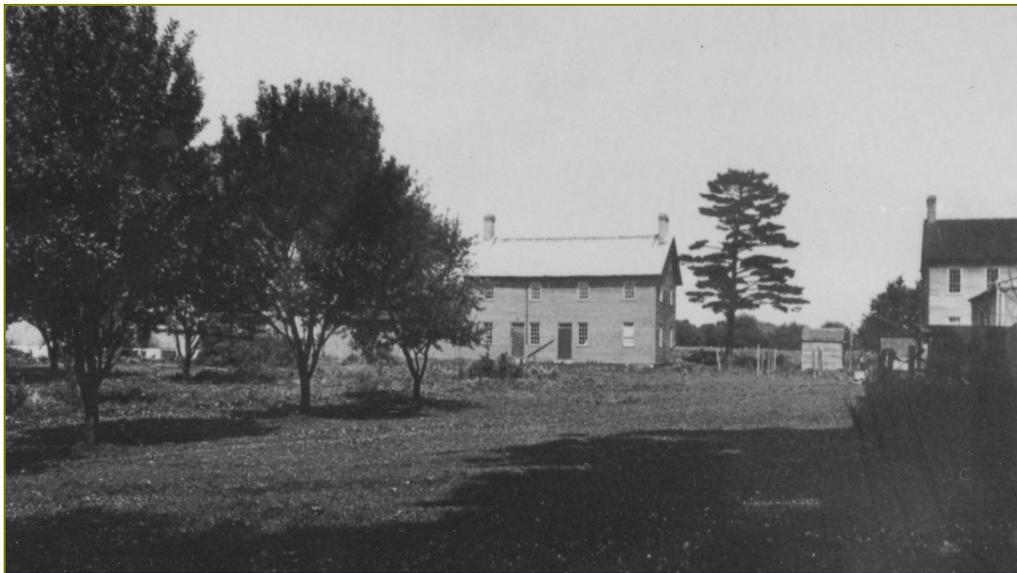
The next photograph that shows the Wash House is also the best known view of the structure (Figure 73). The photograph was taken ca. 1910 and shows the Wash House in the center of the frame, with a privy and the Nurse Shop visible to the right of the building. The shed porch attached to the Kitchen is just visible at the right edge of the picture. The Sisters' Shop is barely visible through the small orchard on the left, and the cistern can be discerned as a low circular weedy area with a large pump handle just in front of the Wash House.

The ca. 1910 photograph shows that the Wash House was a two-story frame structure with four bays of windows with six-over-six panes. The two doors visible on the west face of the building break up the otherwise symmetrical façade of the building, set very near to the left sides of the two center windows. Two brick chimneys are present on the gable ends of the building, protruding from the roof. The one-story shed addition is barely visible on the north end of the building.

**Figure 73. Wash House, ca. 1910**

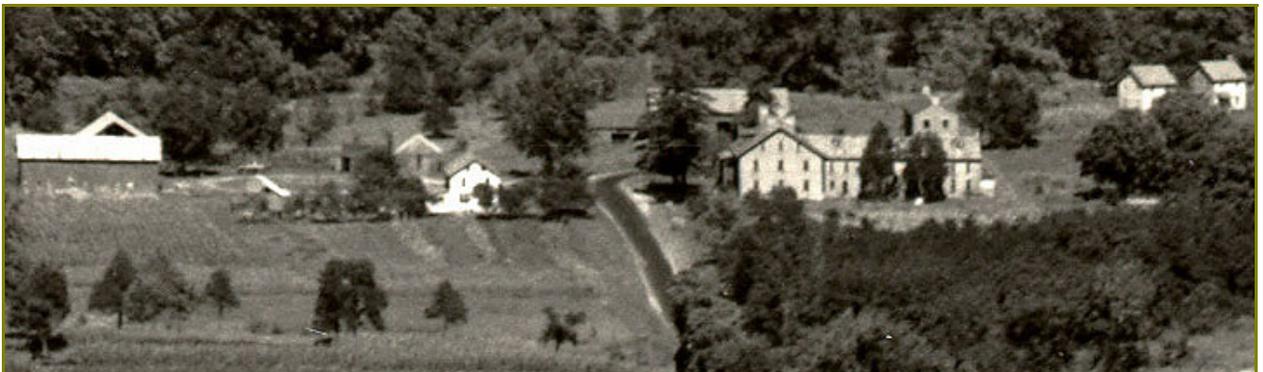
**Figure 75. Detail of ca. 1930 aerial photograph, showing the North Family Lot; split Wash House shown in upper right corner**  
Image courtesy of Otterbein Homes Museum & Library

- A ca. 1930 aerial photograph of Otterbein Homes at the Center Family location, with the North Family Lot visible in the background (shown as an enlarged detail in Figure 75)
- A ca. 1930 view of the North Family Lot taken from the middle of the road, facing southwest (Figure 76)
- The 1937 HABS photograph of the Sisters' Shop, with the Wash House in the background (Figure 77)

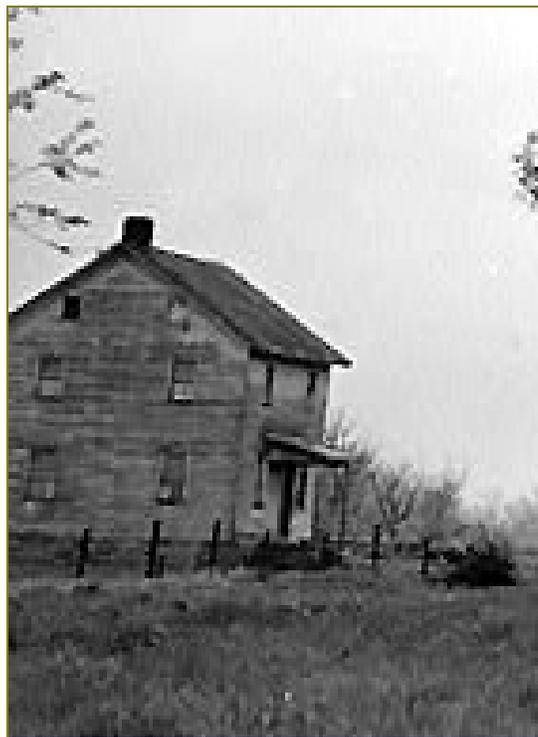
**Figure 76. View of North Family Lot, facing southwest, ca. 1930**  
Image courtesy of Otterbein Homes Museum & Library

The three photographs above suggest that only the original frame-shop portion of the Wash House was used for housing. The original structure may have been five bays by two bays in size, with the central bay removed in 1917 by the split, leaving each half of the structure as a two-bay by two-bay building. The ca. 1930 photographs shows the houses were whitewashed. By 1937, only one of the buildings constructed from the former Wash House was still standing, and it appeared dilapidated. Otterbein Homes likely demolished the last remnant of the Wash House sometime shortly after the photograph in Figure 77 was taken.

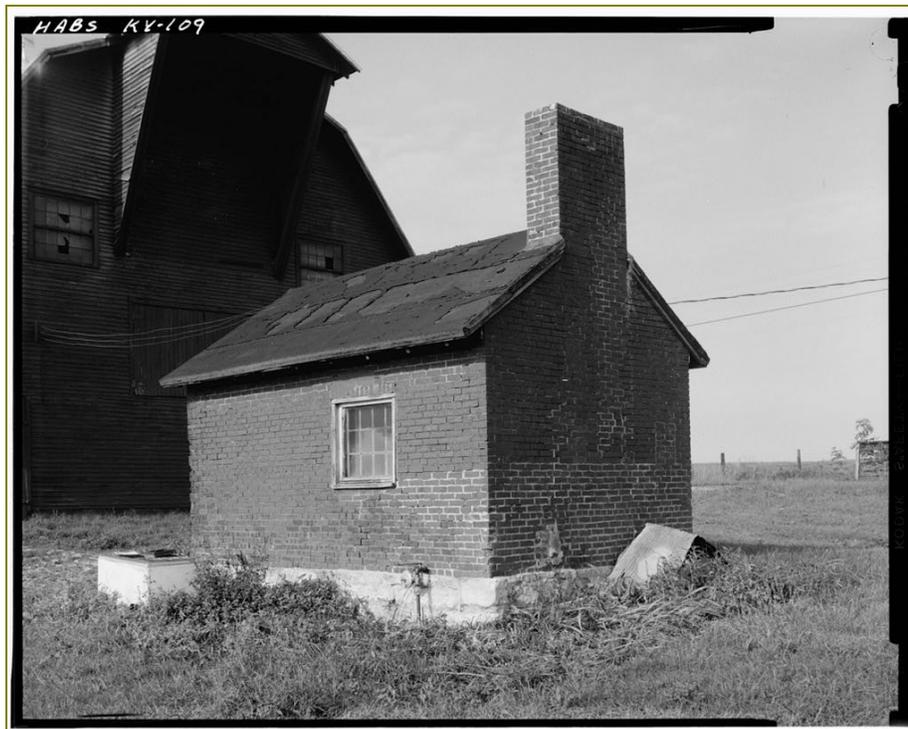
**Figure 78. Dry house at Center Family, South Union, Kentucky**  
(Historic American Buildings Survey 1971)

A HABS photograph of a drying house at the South Union, Kentucky, Shaker settlement shows a small one-story, gabled brick building with a chimney on the end (Figure 78). The building is the size of a small one-car garage. A dry house is represented on the 1835 Kendall reproduction of the 1834 Youngs East House map as a small gabled, one-story building. No definite archaeological evidence was found for a dry house at the North Family Lot, although the foundation remnants located at the northwest corner of the Sisters' Shop may be related to the dry house that was moved in 1854. Also, a small building identified through the geophysical survey that was located east of the Nurse Shop could have been a dry house.

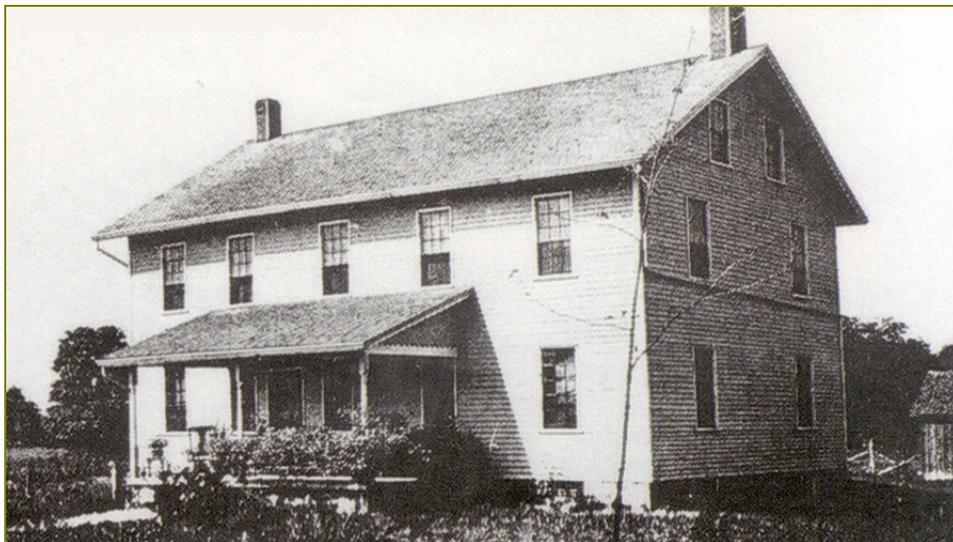
**Figure 80. Former Nurse Shop, ca. 1920, in new location across from Communal House**  
Image courtesy of Otterbein Homes Museum & Library

The Nurse Shop was constructed in 1844. Located behind the Kitchen, it was a two-story frame building with ten rooms and a basement. The shop resembled a typical Shaker frame shop building and measured 38 feet by 25 feet. The function of the Nurse Shop was to house and take care of ill Shakers, and to separate Shakers with contagious diseases from the general population. The building stood at the North Family Lot until 1919, when it was moved across the road to house a tenant farmer. A fire in the 1920s damaged the building, but it was later renovated and probably was occupied up until the ARMCO Park was established in the mid-twentieth century. The only known photographs that focus on this building are from after it was moved by Otterbein Homes (Figure 80, Figure 81).

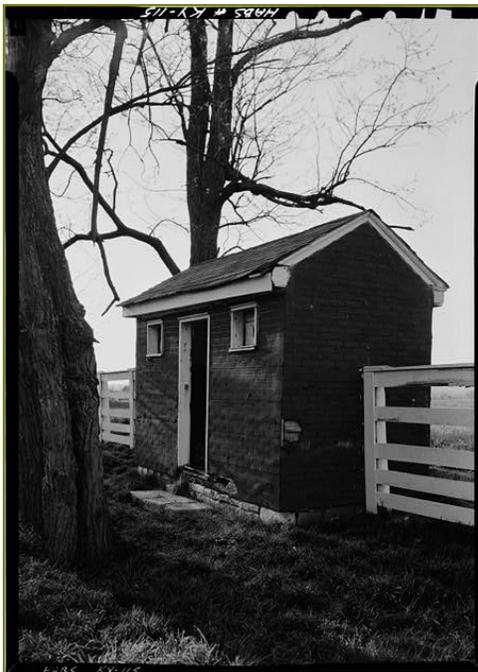
**Figure 82. Privy at Pleasant Hill, Kentucky,  
built in 1858**  
(Historic American Buildings Survey 1963)

The Shakers may have had a common form for their outhouses, as shown in the following three figures: a photograph of a privy from Pleasant Hill, Kentucky, built in 1858 (Figure 82); a HABS survey photograph of a privy at Harvard, Massachusetts (Figure 83); and a HABS drawing of a privy at the West Family at Watervliet, New York (Figure 84). These three representations of Shaker privies show rectangular frame buildings with side-gabled roofs and a central door. Two small windows are present near the roof line on either side of the door. The privy at Harvard, Massachusetts, also featured a large window at the rear of the structure that apparently was designed for removing the waste in the containers below the seats. Small vent holes would have been present near the peak of the roof on each end of the privy. These privies were intended to be used by several people at the same time, possibly up to five or six people at once. Compare the three photographs below to Figure 73 on page 116, which shows a similar structure located to the south (right) of the Wash House at the North Family Lot. The 2004 geophysical survey indicated a possible privy at that location; however, we could not confirm it as it was located outside of the right-of-way.

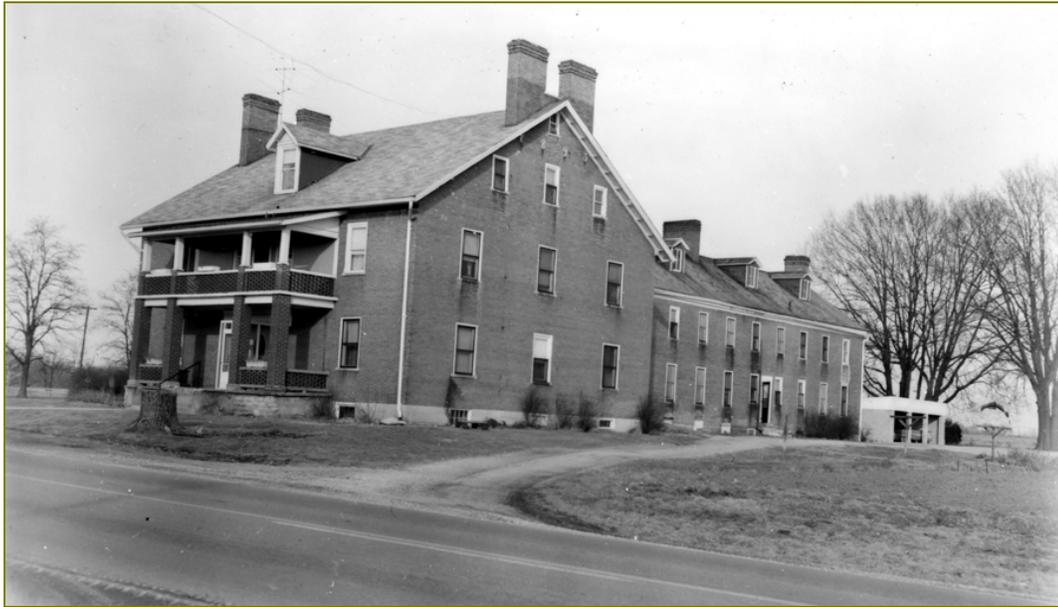
**Figure 85. Communal House, ca. 1960, with garage visible at rear of house**  
Image courtesy of Otterbein Homes Museum & Library

A simple open-sided garage or car port was built sometime in the 1950s at the site, visible in a ca. 1960 photograph of the communal dwelling (Figure 85). This structure represents the last building constructed at the North Family Lot.

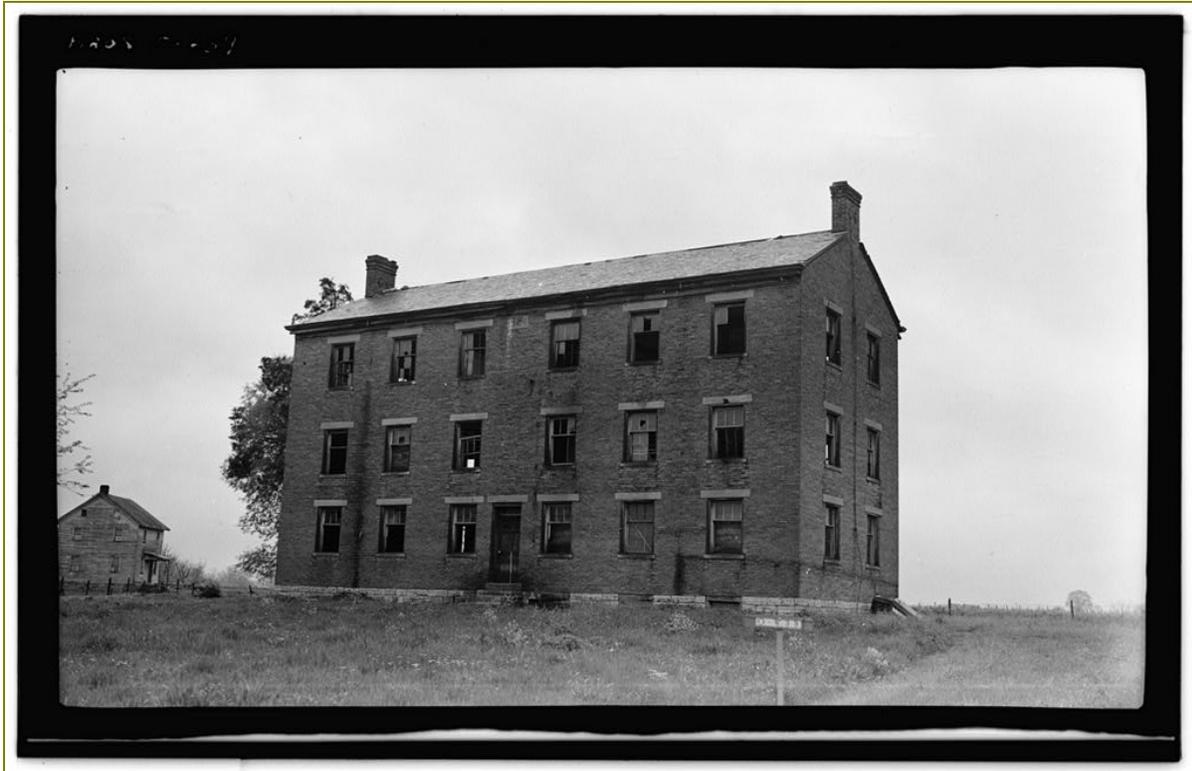
Figure 86. Uncropped 1937 HABS photograph of the Sisters' Shop, showing possible drive in lower right corner

We found evidence for two types of paths at the North Family Lot: flagstone paths put down by the Shakers, and gravel paths and drives associated with the post-Shaker occupation in the twentieth century. We knew from the 1917 Otterbein Homes map that flagstone paths were present at the North Family Lot, and mid-twentieth-century photographs of the Communal House show a gravel driveway (Figure 85 on page 131). A potential drive or path is visible in the 1937 HABS photograph of the Sisters' Shop (Figure 86), although it is unclear if this is actually a former drive or simply where some vehicles have driven over the lawn.

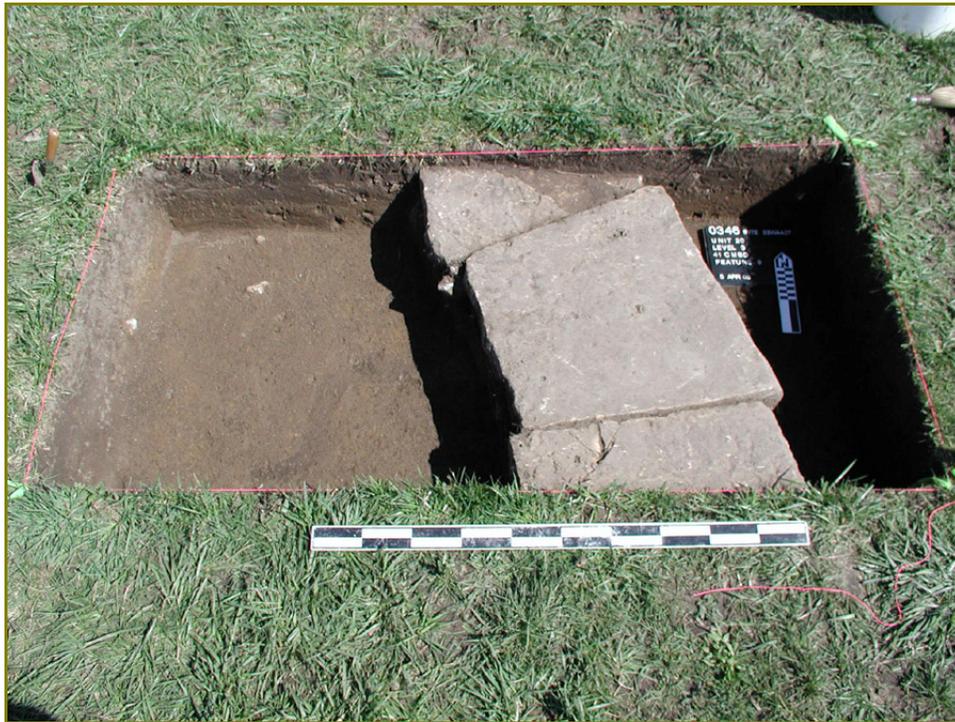
Figure 88. Path 1, as exposed by Unit 20, facing north

The geophysical consultants identified six potential paths from the magnetometer and resistivity surveys, and labeled them as Paths 1–6 (Figure 87). The geophysical consultant interpreted Paths 1–3 as paths from the Shaker period, with Path 1 and Path 2 being flagstone paths and Path 3 a footpath lacking flagstones. The remaining paths were interpreted as post-Shaker in origin. Archaeological excavations verified that Paths 1 and 2 were indeed flagstone paths (Figure 88, Figure 89). Path 3 was not within the project right-of-way and was not tested. Path 4 appeared to be a combination of a utility trench and gravel path. Path 5 was the gravel drive visible in the 1960s photograph of the Communal House, and Path 6 turned out to be a line of drain tile and not a pathway.

The flagstone paths at the North Family Lot were made from locally available limestone and were two feet wide. We do not know for sure when the first flagstone paths were installed, but Shaker journals first mention their existence in 1842: “June 9: We finished laying the stone walk between the dwelling house and the brick shop” (Union Village Diarist 1836–1857:377). On June 11 of that year, another flagstone path was completed leading to the Green Shop, probably corresponding to Path 1 (Union Village Diarist 1836–1857:377).

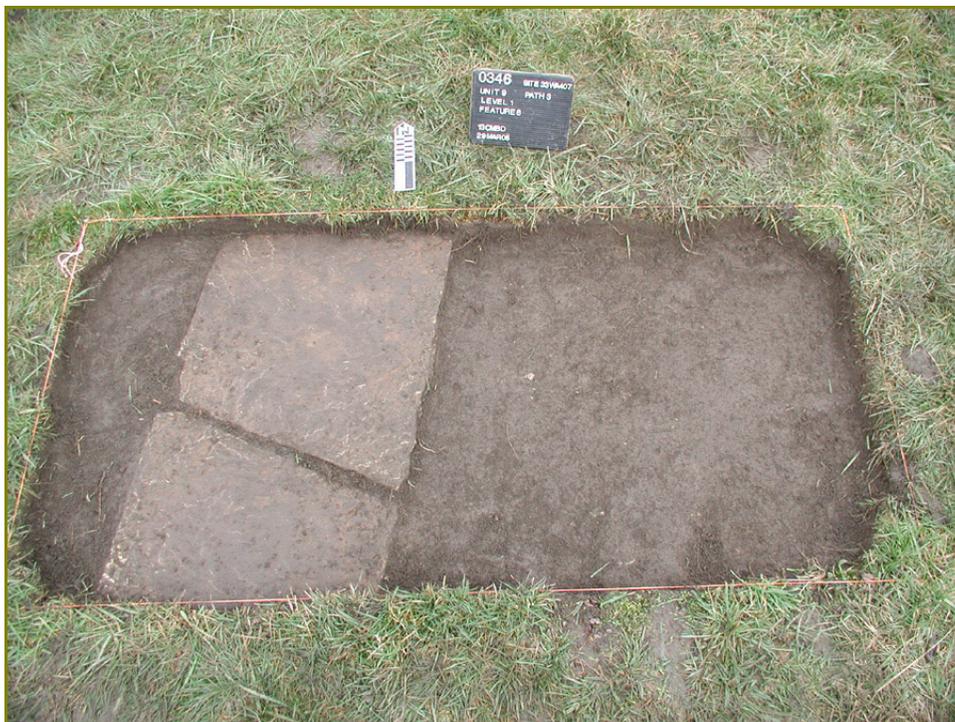
Figure 89. Path 2, exposed in Unit 9, facing north

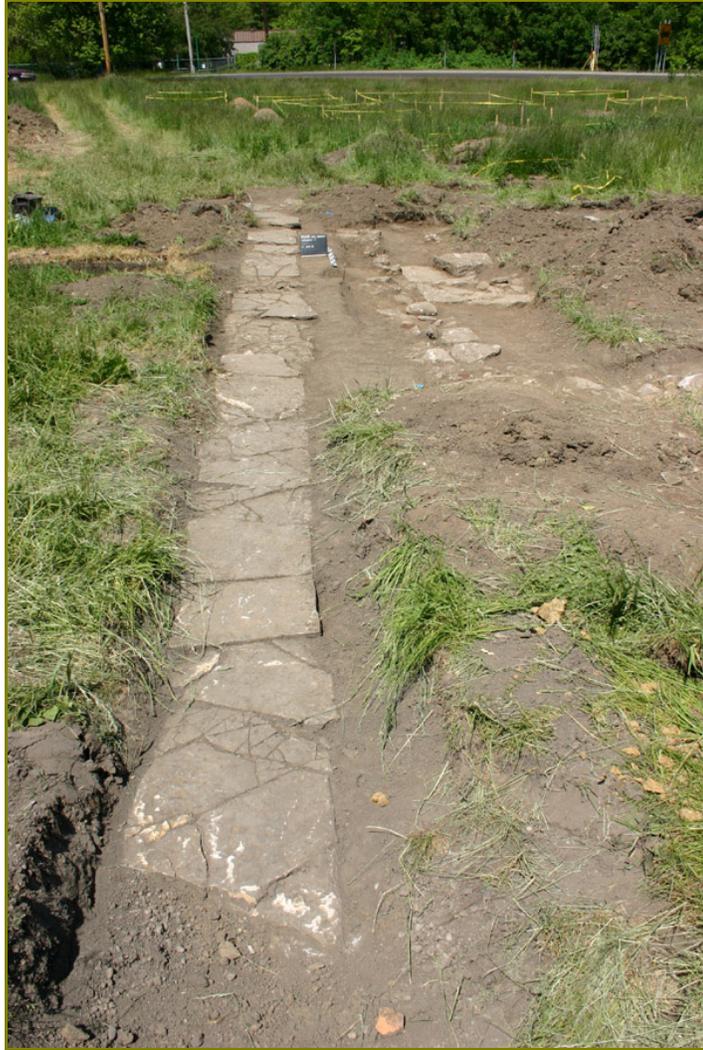
**Figure 90. Path 7, facing west**

Interestingly, all the post-Shaker paths identified in the geophysical survey also had utility trenches associated with them. A third flagstone path, Path 7 (Figure 90), was found during excavations at the Green Shop. This path was not identified by the geophysical consultants in the survey data, but the location of Path 7 in the resistivity data does reveal a faint line that corresponds to this path. Other flagstone paths known to have existed at the North Family Lot, as indicated by the 1917 Otterbein Homes map, were not found, although test units were placed in their locations.
