# ENCOUNTERING THE SHAKERS OF THE NORTH FAMILY LOT, UNION VILLAGE, OHIO

## *A Clean and Lively Appearance — Landscape and Architecture of the North Family Lot*

VOLUME 2 OF A 4-VOLUME MONOGRAPH SERIES

January 30, 2009

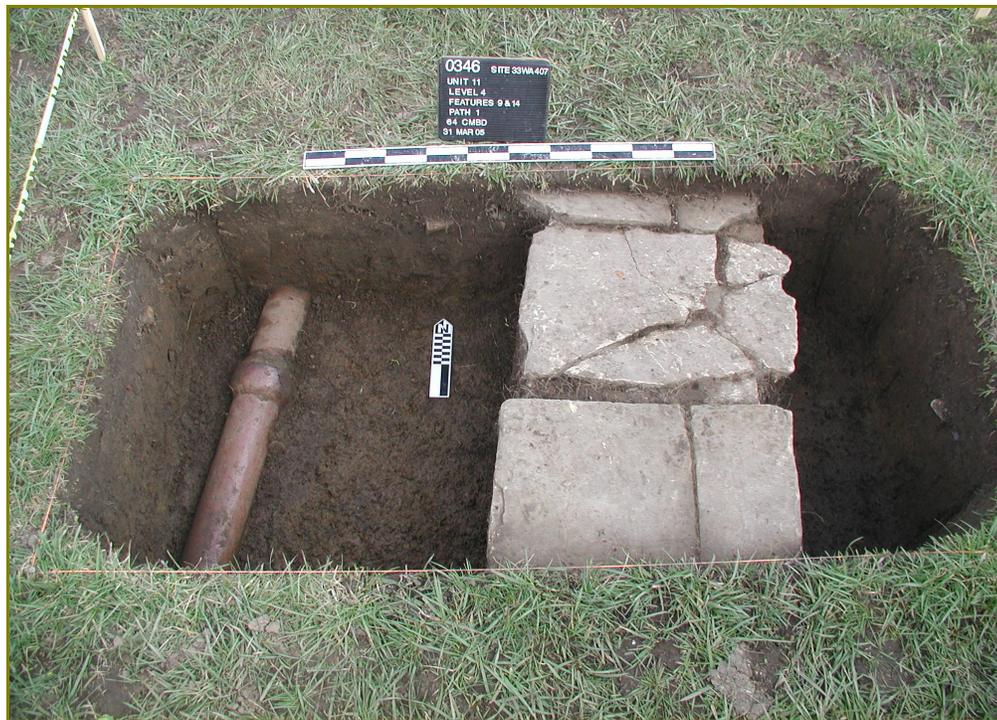
Figure 91. Unit 11, showing ceramic water pipe placed parallel to Path 1, facing north

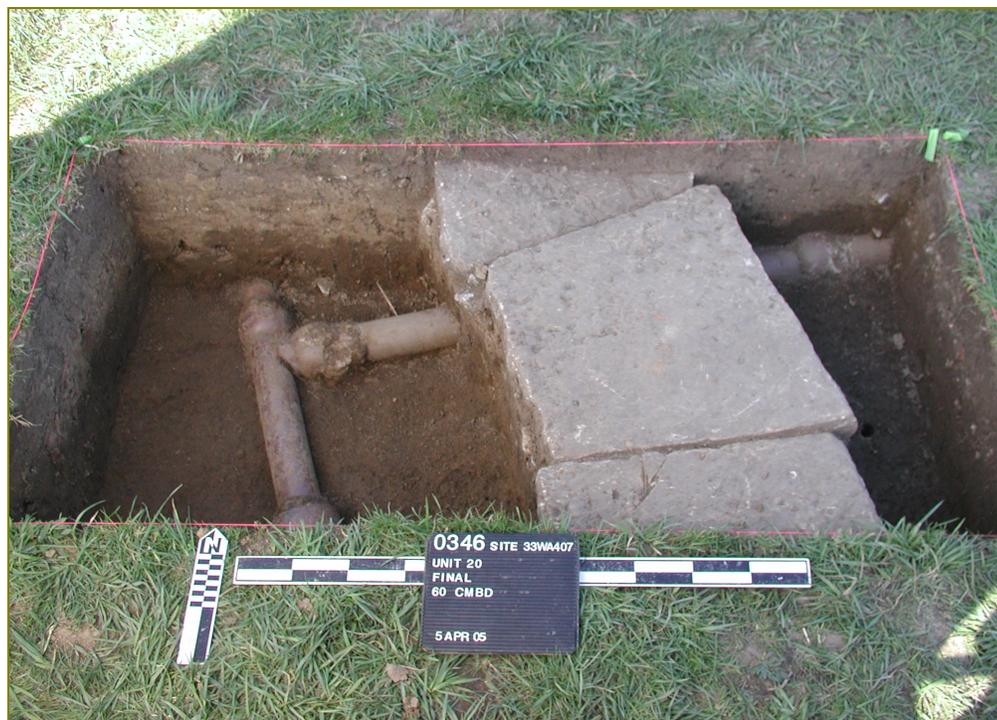
Figure 92. Unit 20, showing junction of two ceramic water pipes in association with Path 1, facing north

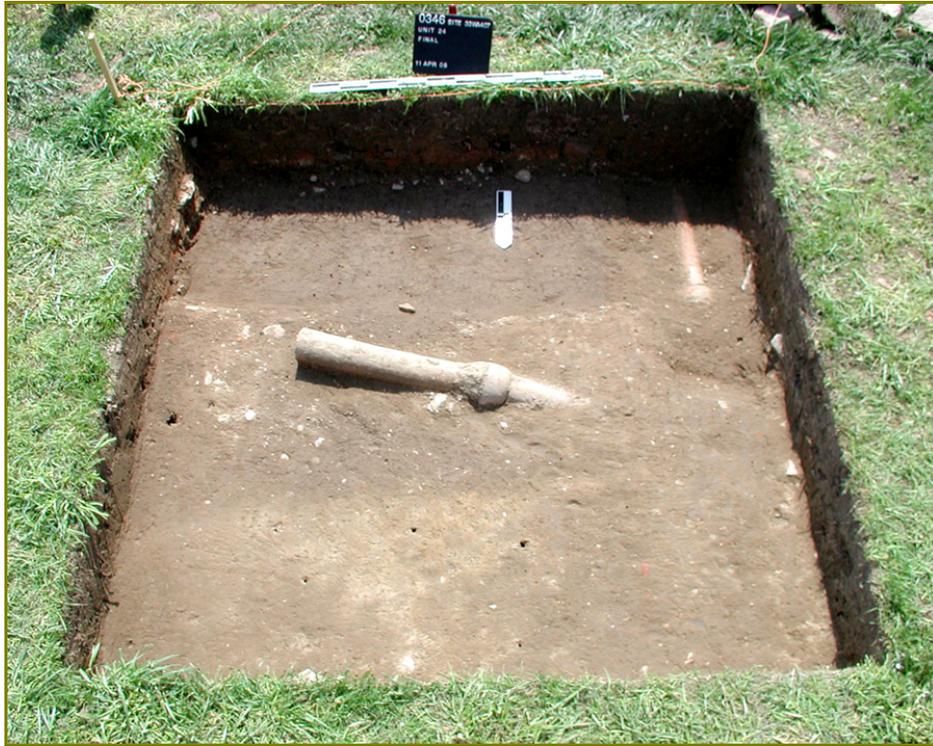
Figure 93. Unit 24, showing angled water pipe, facing south

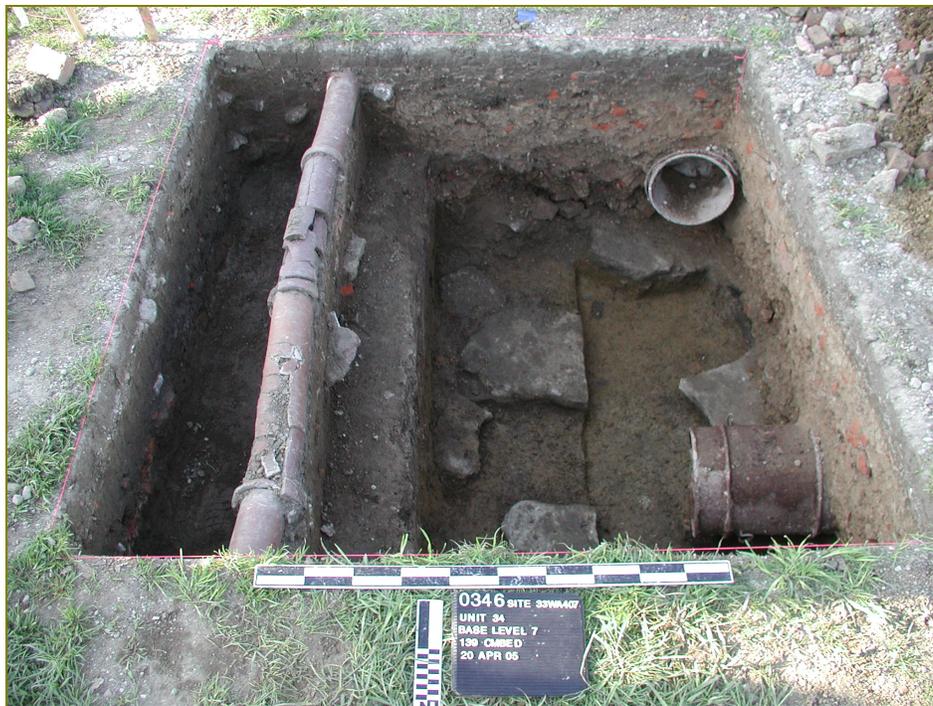
Figure 94. Unit 34, showing water pipe on east side of Sisters' Shop foundation, facing south

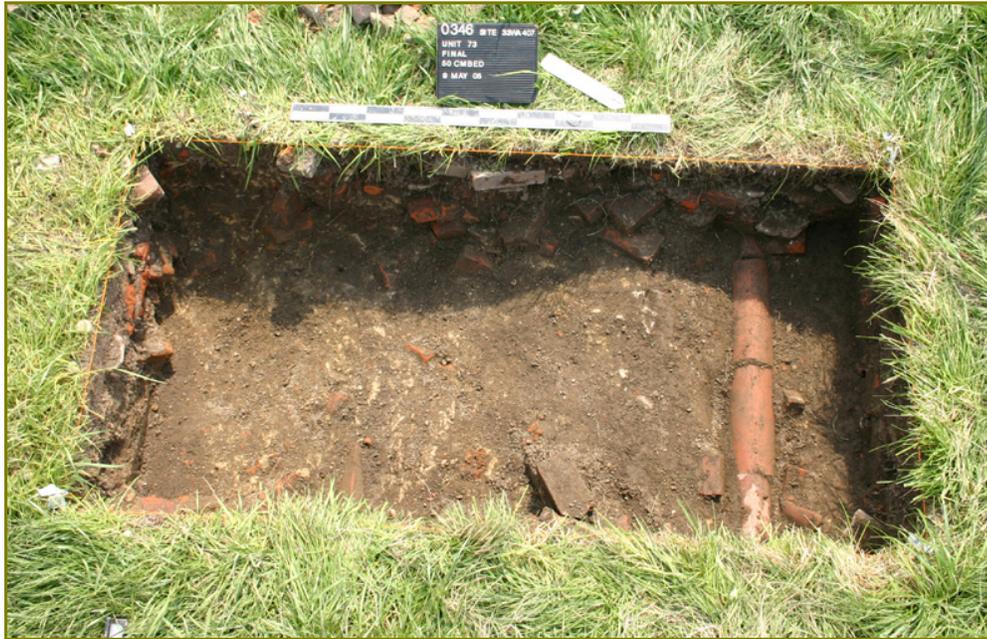
Figure 95. Unit 73, facing southwest, showing drain pipe

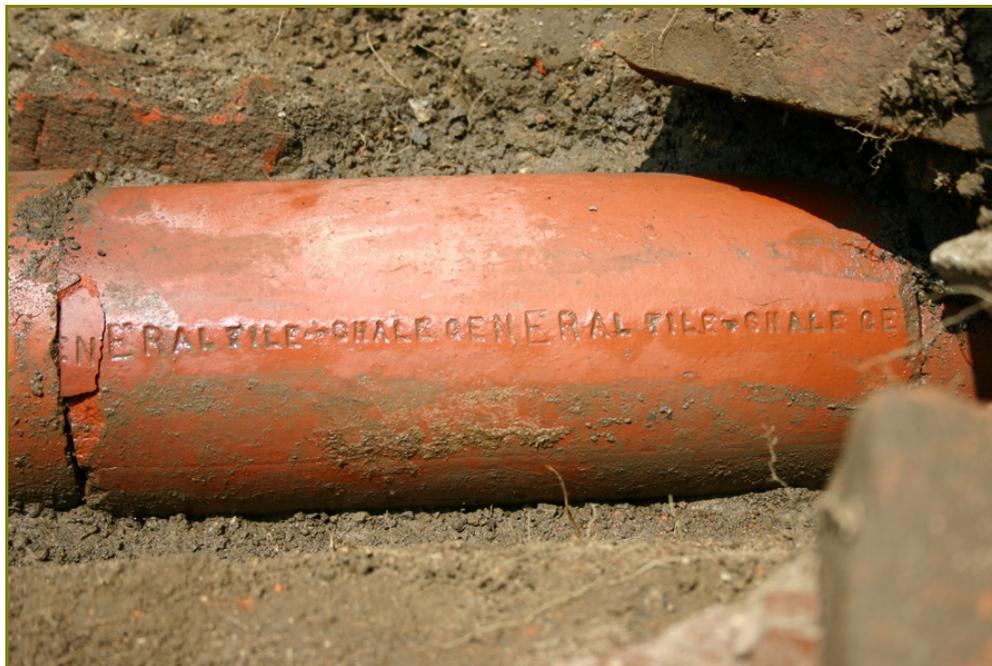
Figure 96. Detail of drain pipe in Unit 73, showing stamped company name

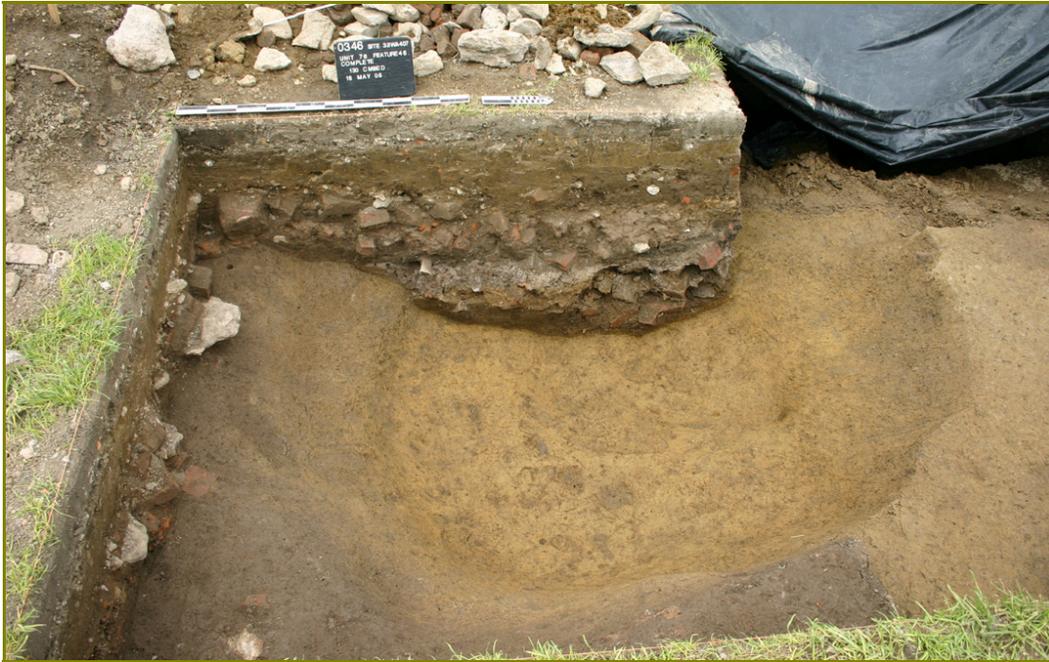
**Figure 99. Rubbish pit at southwest corner of Sisters' Shop (Feature 46)**

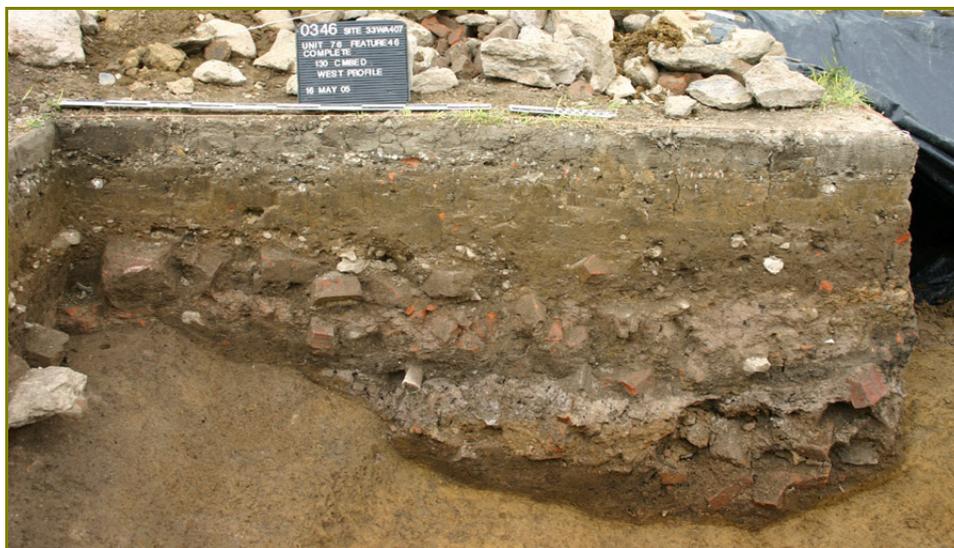
Eight different soil layers were identified in the pit itself (Figure 100). The top layer of fill was a dark brown silt loam. The next layer was a yellowish brown silty sand layer with a very high mortar content, present in the center of the pit. Under this layer was dark yellowish brown clay, present in the northern portion of the pit feature, representing an out of place layer in this pit, due to the fact that it contained a canning jar lid that postdated 1886; the rest of the pit contained artifacts dating to the 1830s and 1840s. An ash deposit present in the southern portion of the pit feature contained the bulk of the recovered artifacts. Below this layer was a very dark grayish brown silt with high amounts of charcoal and ash. Another ash deposit with a silty texture was present below the charcoal and ash-rich dark grayish brown silt. A pocket of silt with a high mortar content was present in the southern portion of the pit. The last stratum of pit fill was a brown silty clay loam.

Figure 100. Rubbish pit at Sisters' Shop, showing profile of soil layers

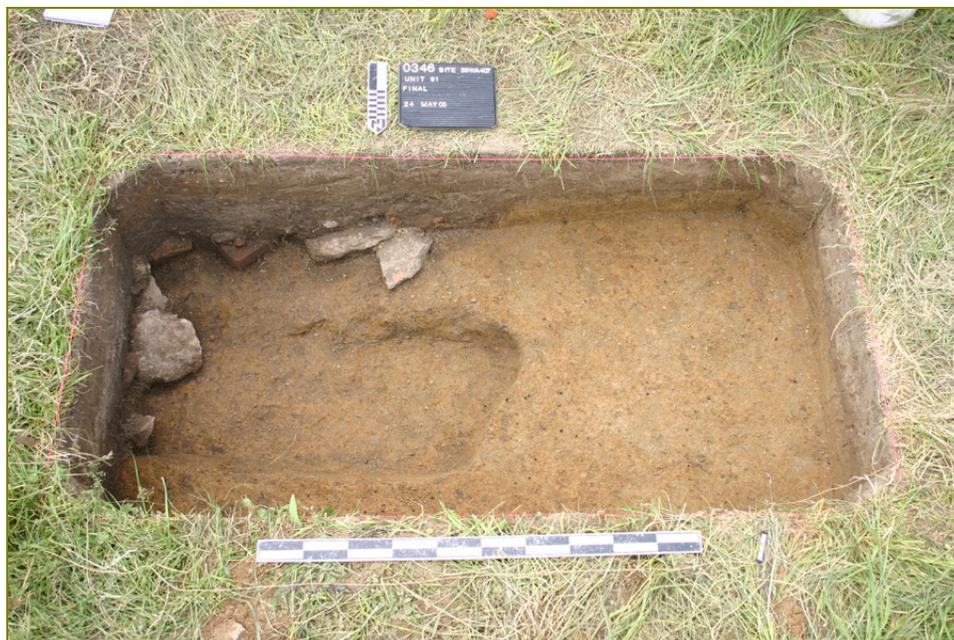
Based on comparisons of the excavation and magnetometer data, the entire feature was a large, shallow, irregularly shaped pit, with maximum dimensions of 16.5 feet by 8.25 feet. The pit had a relatively flat bottom, and was only 9 inches deep (Figure 101). The magnetometry data suggests that the contents and depth of the rest of the pit is similar to what was excavated.

Figure 101. Rubbish pit south of the Brothers' Shop

This pit feature was shallow and filled mainly with rubble from a demolished structure. Limestone rubble (171.8 lbs) and brick fragments (61.6 lbs) were present in large amounts, representing most of the pit fill. Only the northernmost edge of the pit was investigated. A total of 93 artifacts were recovered from the pit, consisting of 38 pieces of metal and 55 ceramic sherds.

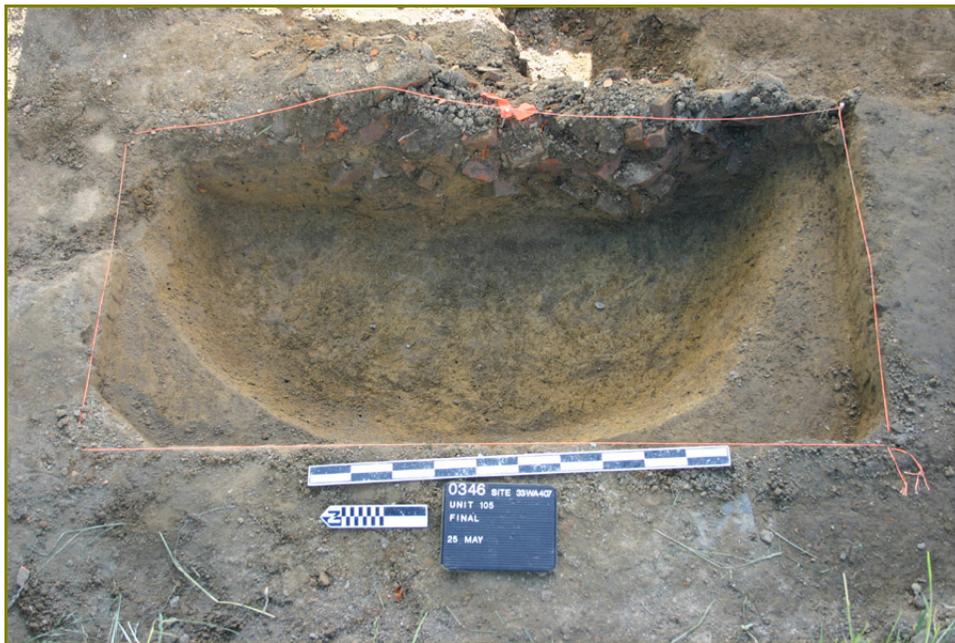
The southern pit, Feature 86, was 5 feet, 2 inches long by 3 feet, 11 inches wide and 1 foot, 6 inches deep (Figure 102). Three distinct soil layers were present within the pit. The majority of the pit was filled with mixed construction material, mainly brick rubble with some slate shingle and limestone cobble fragments. Under the rubble layer was a stratum of yellowish brown clayey silt loam with grayish brown mottles, present to the base of the pit in the south half of the pit but capping another stratum in the north half. The stratum at the base of Feature 86 in the north half was a yellowish brown clayey silt loam with light gray mottles.

**Figure 102. Feature 86, brick-filled construction debris pit**

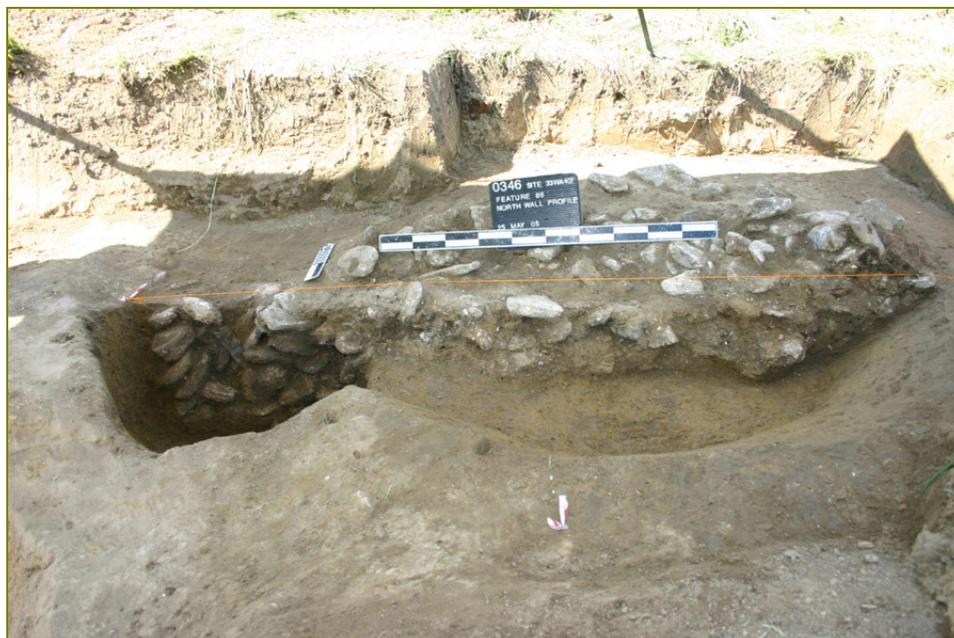
The northern pit, Feature 88, was a shallow basin with a deeper pit present in the western end of the feature (Figure 103). Feature 88 had maximum dimensions of 7 feet, 2 inches by 6 feet, 1 inch; with dimensions of 4 feet, 9 inches by 6 feet, 1 inch for the basin portion and 2 feet, 5 inches by 3 feet, 8 inches for the pit. Using the elevation of the very eastern edge of the pit, which was not severely affected by the backhoe, we can estimate the depth of the basin portion of the feature was 1 foot, 4 inches, and the depth of the pit portion was 2 feet, 1 inch.

Figure 103. Feature 88, limestone cobble-filled construction debris pit
